The Role of Business and Engineering Decisions in the Deepwater Horizon Oil Spill

Mark Reynolds

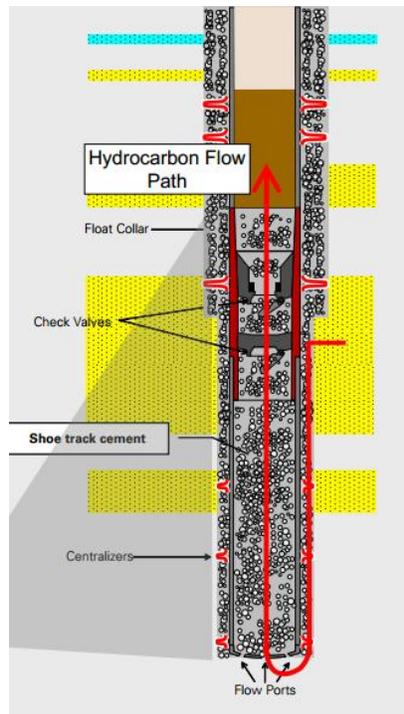
Figure 3 – Hydrocarbon escape into riser [7].

Contractor Halliburton was responsible for design and placement of the cement mixture. Lightweight slurry was required due to limited pore pressure in the area. To achieve the required low density, foamed cement was used. The mixture was created by injecting nitrogen gas into the concrete, which also causes “increased slurry compressibility, increase set-cement elasticity, and the flexibility to vary density during operations” [9]. There were some major risks associated with this cement design and placement, including the fact that the foam was relatively unstable, and was subject to contamination because such a small volume was used. These risks were known and accepted by both BP and Halliburton.

Because nitrogen broke out of the cement slurry, the cement failed and hydrocarbons were able to escape through the shoe track and back into the riser. In addition to the cement failure, an additional check valve failed, allowing hydrocarbons to enter the riser. This valve failure has also been confirmed by Macondo static kill data [7].
