## **The Sinking Of the Titanic**

**Heather Kelly**

Memorial University of Newfoundland  
St. John's, NL, Canada  
t26hmk@mun.ca

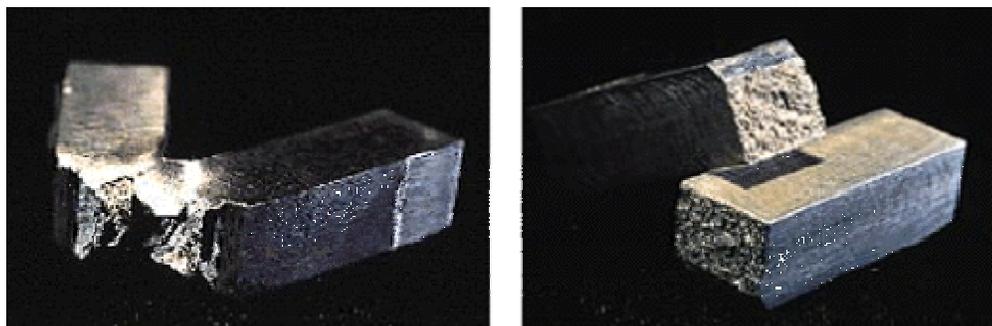
Figure 1 below shows a comparison of Charpy test results of modern steel compared to the test sample from the Titanic’s hull. The modern steel on the left bent without breaking when struck by an impact, while the Titanic’s sample on the right is shown to have broken into two pieces in a brittle fashion under the same impact load. [4]

Figure 1: Results for Charpy Test of Modern Steel & Titanic Hull Steel [3]

Although the composition of the hull steel would be considered excessively brittle by today’s standards due to the excessive amounts of sulphur and phosphorus, specifications at the time only called for “a range of tensile strength and tensile ductility, which is a poor indicator of fracture

toughness.” The Charpy tests had only been devised approximately five years prior to the construction of the vessel and few materials were tested for fracture toughness at that time. In fact, there was little theoretical information about steel notch sensitivity and it would not have been intuitive for the designers of the Titanic to test for a property that was so little understood. [4]

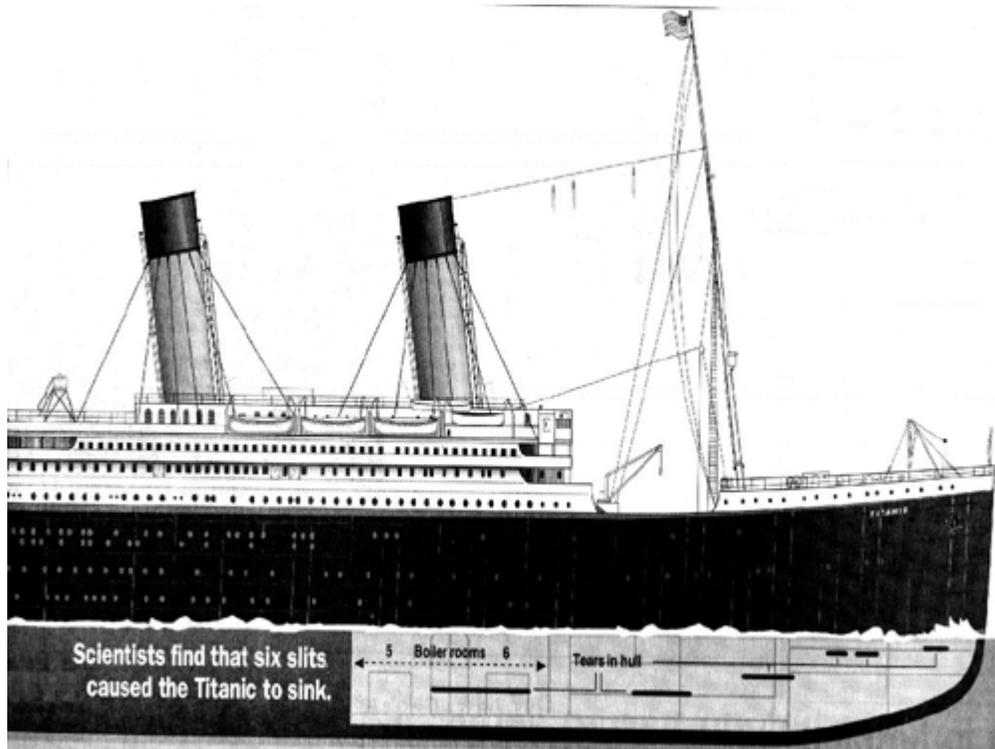
When designing the Titanic and its sister vessels, the Harland and Wolff building company set out to provide an exemplary level of safety for the current times. They did this mainly through subdividing the hulls of the vessels into watertight compartments. Fifteen transverse bulkheads divided the hull into sixteen watertight compartments, and each could be sealed off from the adjoining compartments through mechanized doors in the case of an emergency. [6] However, although these compartments were considered watertight, they were only effectively so in a horizontal direction. The bulkheads were not capped at the top and extended only several meters above the waterline. [7] The ship’s builders claimed that four of the compartments could be filled without adversely affecting the vessel’s buoyancy. However, at least six of the watertight compartments towards the bow were ruptured after the Titanic scraped along the iceberg. [2] As one compartment filled, it spilled over into the next due to the tilt of the sinking vessel. [7] Figure 2 below shows a layout of the watertight

compartments with the thick horizontal black lines representing the approximate locations of the damage to the hull.

Figure 2: Approximate Locations of Damage to Titanic's Hull [3]

Five of the six breached compartments flooded within an hour after impact with the iceberg, and the Titanic sank to the bottom of the Atlantic Ocean in less than three hours. [8]

The White Star Line modified the hull design of several of their existing vessels in two major ways in response to the disaster of the Titanic. The double bottoms of the ships were extended further along the hulls, and the watertight compartments were raised so that they were watertight vertically as well as horizontally. A double bottom is constructed from two layers of steel, separated by a 1.5m gap, spanning the entire length of the ship. If the outer layer of the hull is breached, the inner layer would likely remain intact. By raising the height of the transverse bulkheads, water is prevented from flowing

over the top of one compartment into the next in the case of a breach in the bow compartments. This allows flooding to be isolated and contained to damaged sections. [3]
