## The Capsize of the Drillship Seacrest

**David M. Mannion**

### ABSTRACT

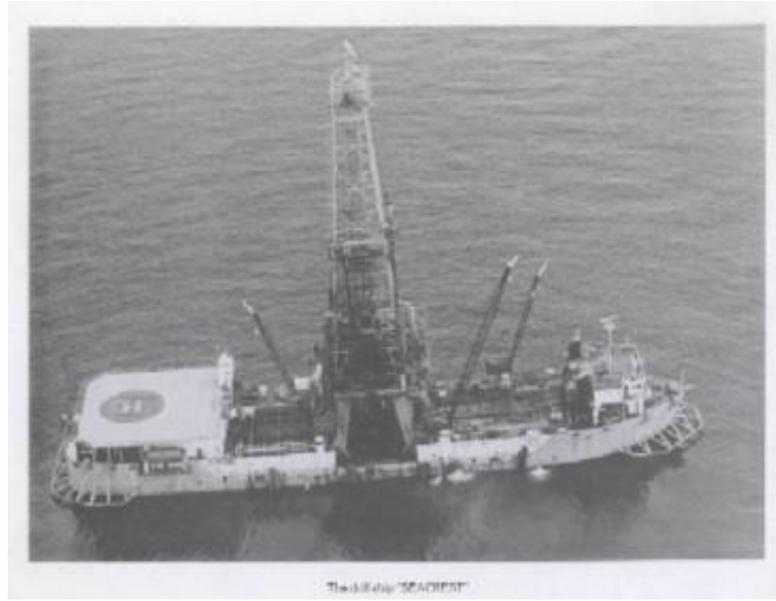
Figure 1: The Seacrest

The Seacrest was owned by the Seacrest Drilling Company, and operated by the Great Eastern Drilling and Engineering Company, for Unocal, which later merged with Chevron. It was 362 feet long, 70 feet on the beam, and 24 feet deep. It was built in 1977 by Far East Levingston Shipbuilding Ltd in Singapore, and was classed by the American Bureau of Shipping, with an A-1 Drilling Unit class. It was registered in Panama. The Seacrest began drilling gas wells for Unocal in the Gulf of Thailand in 1981. On October 23<sup>rd</sup>, 1989, the Seacrest made its final rig move. [2]

While drilling, the Seacrest was moored by eight anchors distributed around the ship. Each anchor weighed 30 000 lbs. and was connected to the ship by 2 inch wire rope. All of the cables were replaced during the summer of 1989. [2]

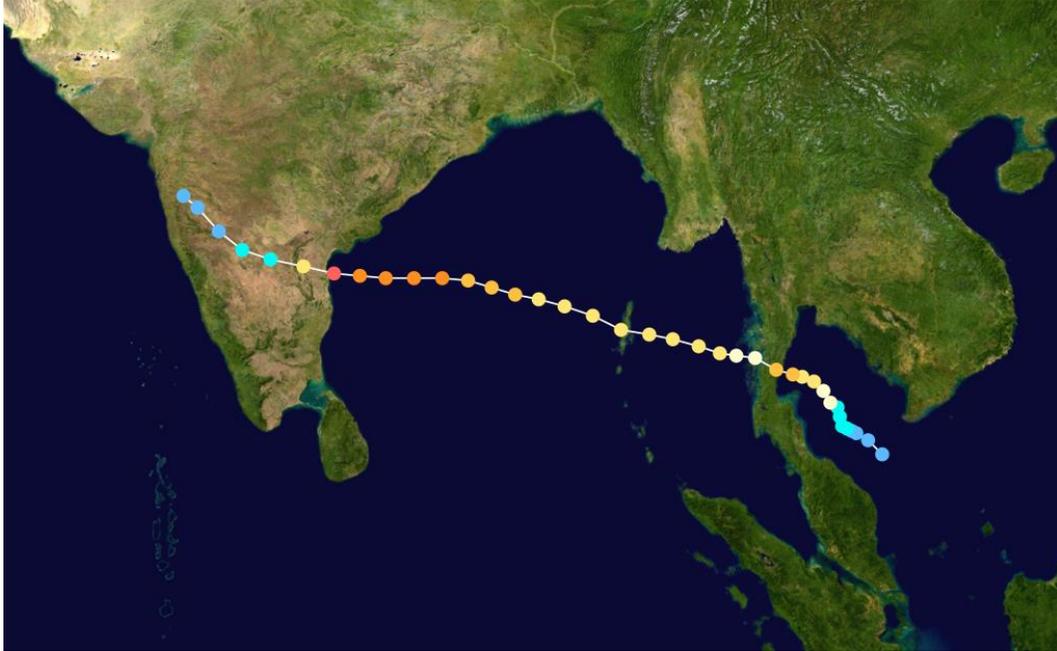
Figure 2: The Path of Typhoon Gay (1989) [4]

Typhoon Gay was a category five typhoon, which means it had wind speeds upwards of 252 km/hr or 136 knots. It was the first typhoon seen in the Gulf of Thailand in eighteen years, and the first hurricane to form in the Gulf of Thailand in forty. Significant wave heights near the Seacrest were estimated at nineteen feet. It started out as a mild depression, and was originally forecast to miss the Seacrest altogether. However, during the night of November 2<sup>nd</sup>, 1989 the depression rapidly intensified and its direction of travel veered north towards the Seacrest. At this point Unocal realized that the weather was much more serious than anticipated and began to prepare for a storm with very little time to spare. There were several oil developments in the Gulf of Thailand and they were all taken by surprise. Every ship that the storm passed over reported stronger winds and lower pressure than the last. Between 1130 and 1200, the eye of the storm passed over the Platong Living Quarters, which reported hurricane force winds, and that the eye was headed for the Seacrest. At 1217 the eye passed over the Seacrest. While in the eye of the storm, the Seacrest was able to make a report. There was only one anchor out of eight remaining after the first pass of the eye wall, and the ship was taking on water in its mud room. Minutes later all communications ceased and the Seacrest disappeared from radar.
