The Loss of the Sleipner A Platform

Justine Barry

Memorial University of Newfoundland
St. John's, NL, Canada
justine.barry@mun.ca

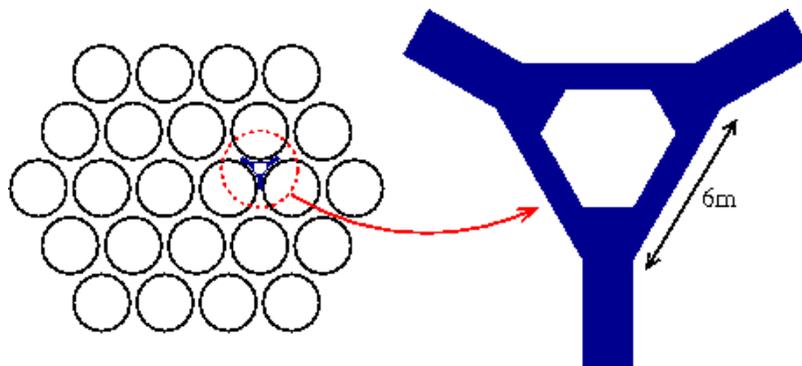
Figure 2 – The Triangular Void called a Tricell [4]

The Sleipner platform was designed with 24 cells, 4 of which extended as shafts to support the deck structure. The gravity base covered an area of 11,900m² and the shafts were at a height of 110m above the base. The exterior walls of the cells were circular with a radius of 12m, while the interior walls which separated the cells were straight [3]. The intersection of the interior walls formed a triangular void called a tricell; there were 32 tricells in total present on the Sleipner Platform as shown in **Error! Reference source not found.** below. The walls of the tricells had to resist substantial hydrostatic pressure due to openings at the top which filled the tricell with water once the tops of the cells were submerged. The tricells were later discovered in the investigation to be the point of failure in the sinking of the platform.

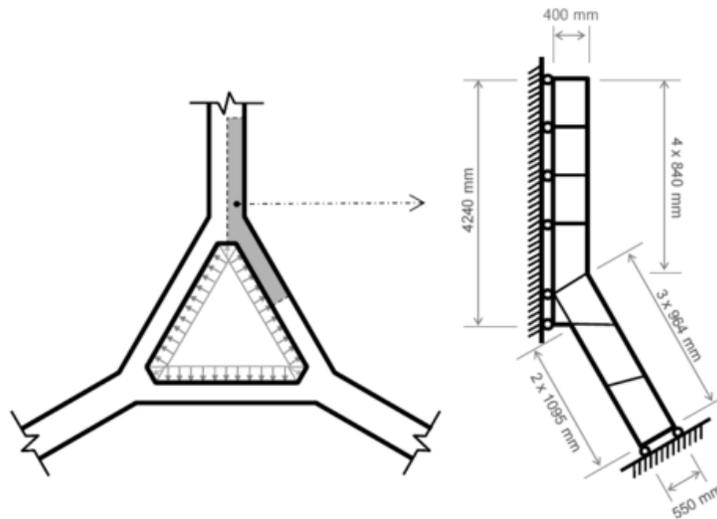
Figure 3 – Tricell Element Model [6]

The investigation identified the tricell walls and their supports to be the only area with significant weaknesses. Calculations also showed that the load at the time of the accident was at or near the ultimate capacity of these walls, and sinking scenarios confirmed that a single leak from one tricell joint could result in enough water entry to sink the structure within the observed time [1]. Analysis of stresses in the tricell joints was accomplished using the linear elastic finite element program NASTRAN, which had been developed by NASA [6]. The investigation identified that the reason for the weaknesses and reduced load-bearing capacity was due to the unfavourable geometric shaping of some finite elements in the global analysis, see Figure 3 below. As a result, the shear forces at the walls of the supports were underestimated by approximately 45 percent, leading to failure.

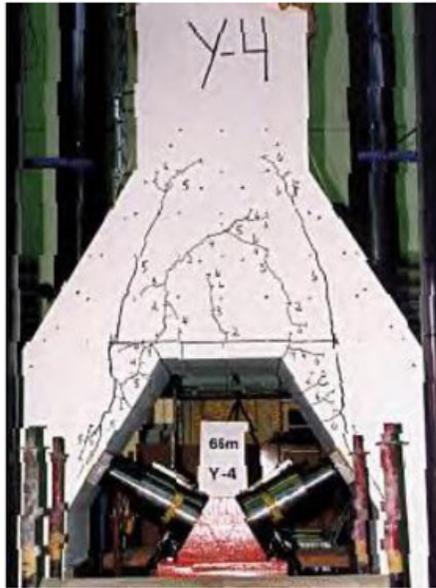
Figure 4 - Experiment test of a tricell joint [4]

The investigation team also used an alternative analysis approach, in addition to examining the finite element modelling. Specifically, the method of strut-and-tie modelling was examined. Strut-and-tie modelling approximates a reinforced concrete system with a truss mechanism. This method has the advantage of being highly flexible as an analysis technique and better represents the cracked, plastic behaviour of reinforced concrete at its ultimate limit state. Experimental tests of the tricell joints using the strut-and-tie method verified that failure occurred through the tricell, as shown in Figure 4 below.
