## **Assessment Of The MODU *Rowan Gorilla I* Capsize And Sinking**

**Darren Hickey**

Memorial University of Newfoundland  
St. John's, NL, Canada  
k97dmh@mun.ca

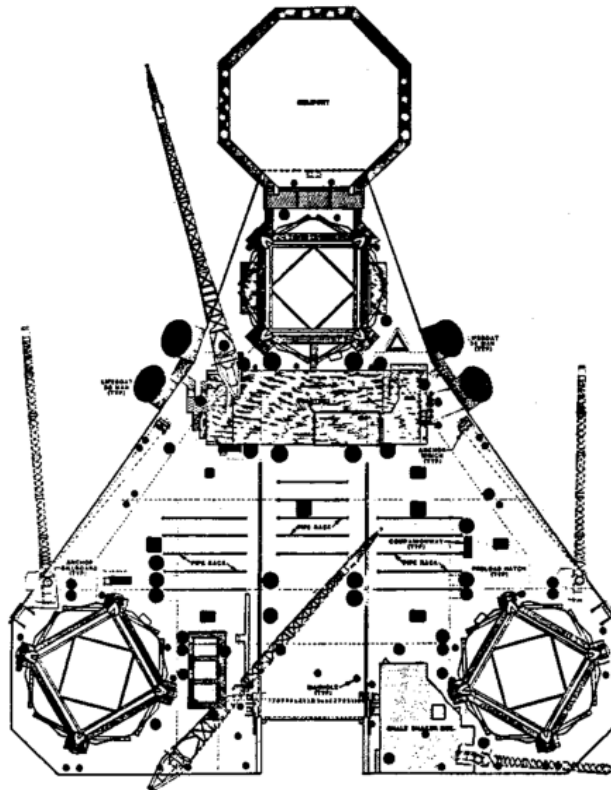
Figure 3-1: Location of *Rowan Gorilla I* Downflooding Points [1]

The deck layout, designed to carry cargo and equipment on an otherwise unprotected deck, proved to be an unwise design given the severe loading due to waves boarding the rig. This green water reduced stability as well as dislocated the majority of the deck cargo, creating numerous downflooding points. The damage caused by the moving cargo was extensive; therefore the forces from both the water on deck and shifting cargo were underestimated. Locations of downflooding points are indicated by the shaded black circles and squares in Figure 3-1.

Given the contributing factors discussed above, the immediate cause of the casualty was the unanticipated and uncontrolled downflooding into a large but unknown number of interior voids and tanks. This resulted in loss of stability leading to capsize, and loss of positive buoyancy leading up to the sinking. The fracturing from the severe weather conditions and oscillations of the legs both compromised the structural integrity of the rig, and allowed the ingress of water. This flooding reduced the freeboard of the rig, and further exposed the main deck to waves and green water. Green water, while reducing stability also compromised the watertight integrity of the deck. Damage to tank vents, access hatches, and fittings caused by hydrostatic pressures from water on deck, along with shifting cargo effectively created extensive downflooding points.
