Bear Cove Coastline Reestablishment

Chris Ryan

Memorial University
St. John's, NL, Canada
Cpr530@mun.ca

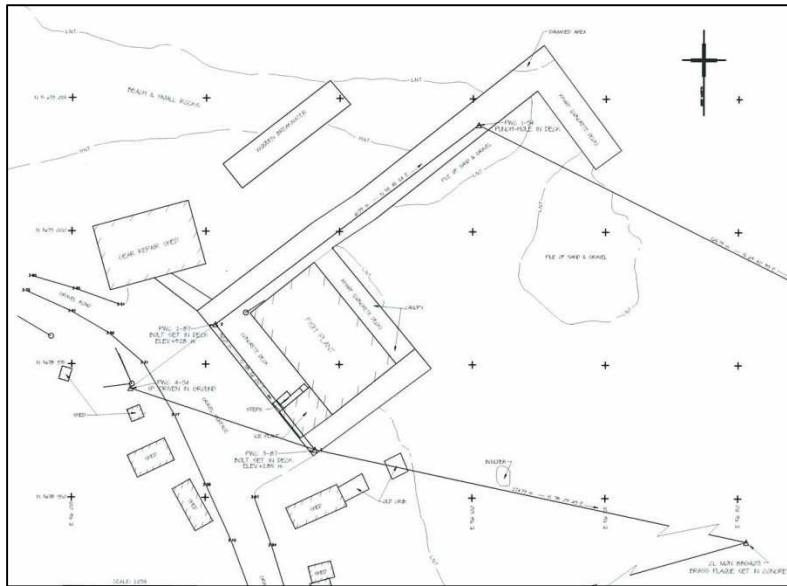
Figure 1 – Former Site Conditions

Following the demolition of the L-shaped wharf seen in Figure 1, the material located immediately west of the wharf (left in Figure 1) began eroding. This resulted in the shoreline being pushed further back nearly to the gear repair shed at high normal tide (HNT). This presented the potential danger of undermining for the gear repair shed which still exists today.

This erosion was the direct result of the wharf removal, which was acting as a groyne. Groynes are structures used to impact the near-shore sediment transport processes to modify beach response to wave and tidal conditions [2]. The wharf forced the deposition of sediment to the west due to the west to east net transport in the location. The reflection of waves from the breakwater and wharf resulted in destructive interference between reflected and oncoming waves. This interference resulted in the loss of energy from the waves and ultimately the settling and deposition of material contained in the water. It can also be noted that on the East side of the L-shaped wharf, a sediment pile can also be seen in Figure 1. This is a result of the loss of energy from the waves diffracting around the wharf structure.

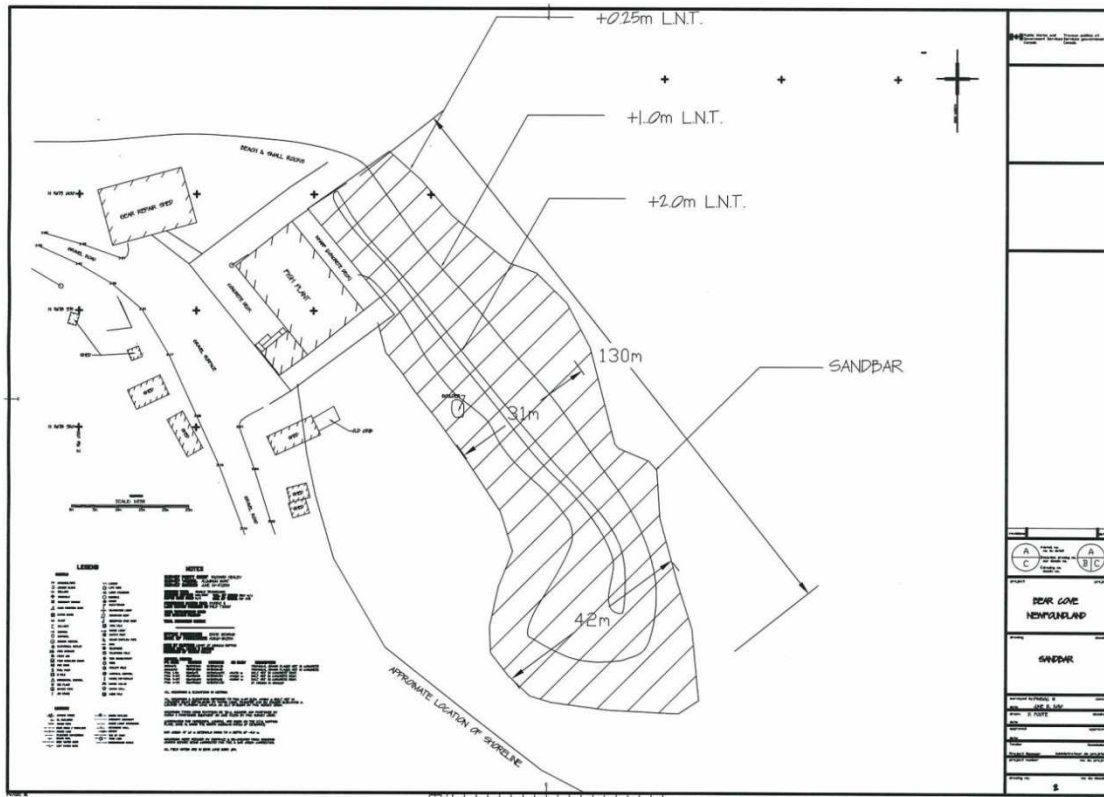
Figure 2 – Sandbar Survey

length and width) over time. Shown in figure 2 are the approximate extents of the sandbar at +0.25 m lowest normal tide (LNT), +1.0 m LNT, and +2.0 LNT in June of 2010.

The measurements of the sandbar were as follows: approximately 130m long, ranging from a width of 30 m to 45 m. The crest was approximately 2 m wide and had an average elevation of +2.55 m LNT. The sandbar was composed of approximately 35% sand and 65% stone. The stone particle size ranged from 25 mm to 600 mm (former protective armour stone located to the west of L-wharf). From the survey of the sandbar on June 12, 2010 it was estimated that 4,000 m³ of the material was located above +0.00 m LNT, and 6,500 m³ was located above -0.25 m LNT.

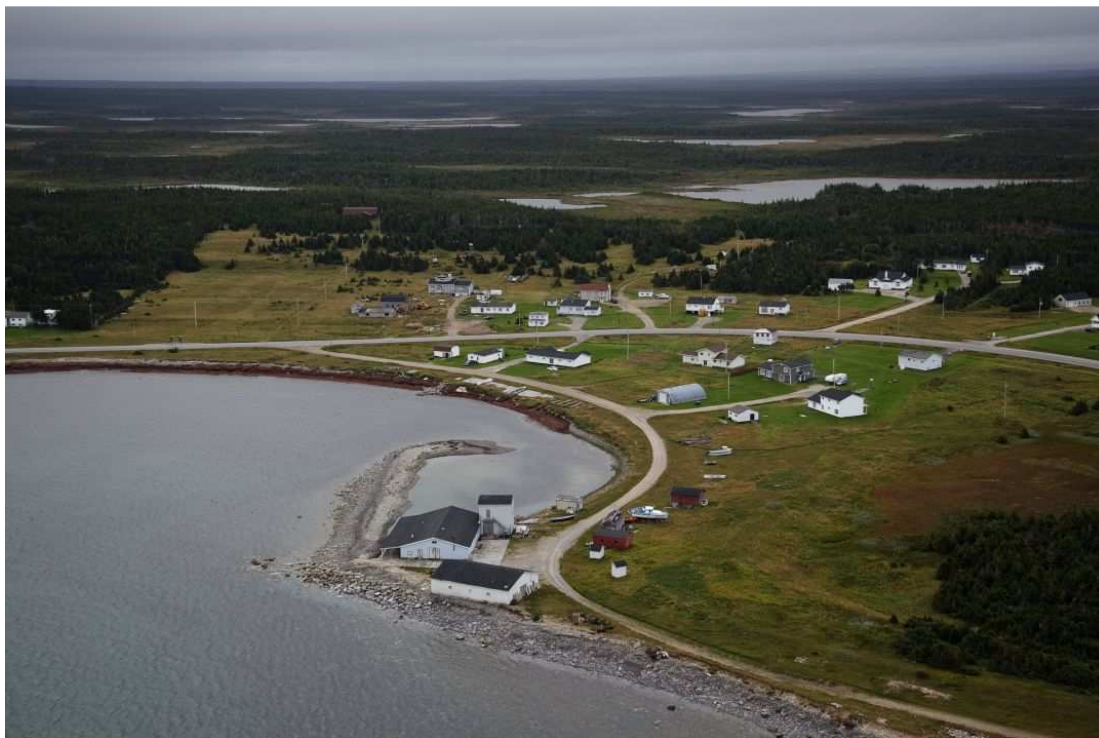
Figure 3 – Sandbar Aerial Photo

As a result of the sandbar formation, a small basin was created behind the sandbar, bordering the east side of the marginal wharf. This basin was becoming increasingly isolated from the ocean as the sandbar increased in size. As the basin became more isolated and protected, the water inside the basin became nearly stationary and received minimal impact from wave action.

Due to the stationary water, at high tide much of the sediment would settle out of the water onto the floor of the basin, resulting in the depth of the basin constantly decreasing. In addition to the sediment deposition, during a rising tide and flow of ocean water into the basin, kelp was also transported into the basin. This kelp would settle to the floor, and while the tide was lowering and water exited the basin, the settled kelp would remain. This process continued for an extended period of time until the floor of the basin was completely exposed at low tide, while still completely submerged at high-tide.

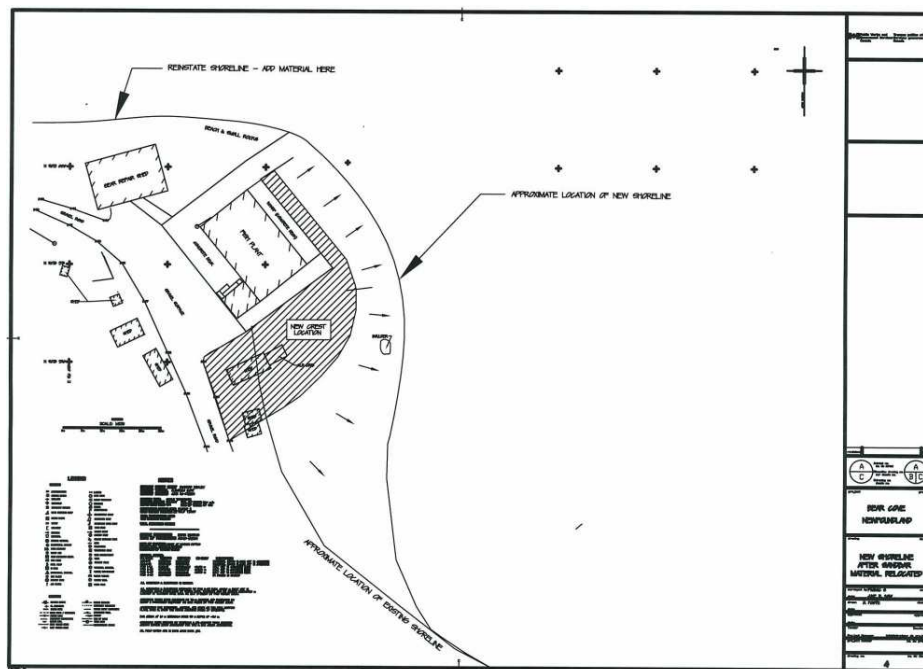
Figure 3 – Short Term Solution

Shown in the following figure (Figure 3) is the intended site view following the completion of the short-term solution.

The short-term solution involved the excavation of the sandbar to a depth of +0.00 m LNT and relocating the material to the shoreline. While this solution immediately address the issue at hand, it was likely that upon completion the deposition of material will continue and the sandbar will begin to reform. Whether a basin would form again would be unknown as the material would be relocated into the current basin location. The detailed outline included in the proposal was as follows [3]:

- 1) *Push the crest of the sandbar to the front of the marginal wharf. This will eliminate the 2m wide space presently between the sandbar and the wharf thus removing the kelp from collecting in this area. Slope the material toward the ocean.*

- 2) *Relocate the sandbar material east of the marginal wharf. Place this material to the intersection of the East side of the marginal wharf and the shoreline. This will remove the sandbar from its present location. It also fills the basin adjacent to the wharf eliminating an area that kelp collects.*

- 3) *Continue this infilling until the fill material until it reaches the berthing face of the marginal.*
- 4) *Relocated the sandbar material to the area west of the gear repair shed. It is presumed a large percent of this material was originally located in this area. This will replenish the shoreline where it has eroded and provide protection to the gear repair building.*

- 5) *Cover all deposited material will armour stone, minimum 2 to 4 tonnes to resist wave and ice action.*

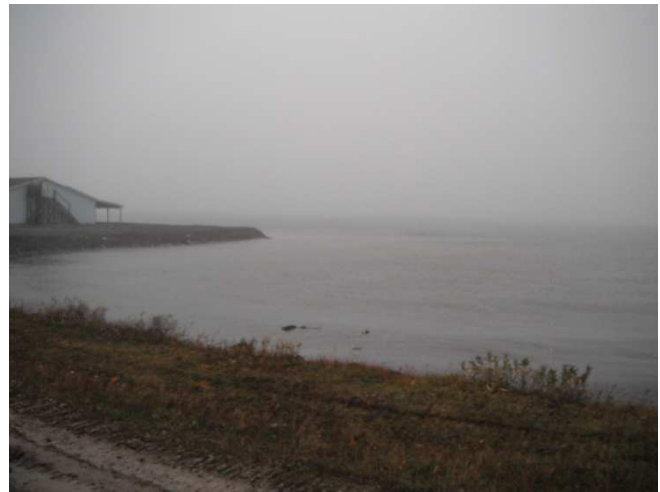
Figure 6 – Bear Cove Project Completion

Upon completion of the project, an immediate flushing effect occurred. In the following days, much of the sludge previously located in the cove began working down the shoreline to the east and out into the ocean. This was a result of the increased wave energy that the cove had been deprived of while the sandbar was in place. It was also noted that the cove was returning to a more even depth. The increased wave energy removed much of the sludge and loose sediment previously located in the stationary basin to more closely match the depth of the entire cove.

On September 29, 2010 the Bear Cove Project commenced and was completed on October 3, 2010 by Floyd's Construction Ltd. The work was completed according to the outline provided in the project proposal with the exception of relocation of material to the north side of the gear shed. Upon further consideration it was determined that this effort would be too futile as the natural process of the ocean would quickly remove the material once again. PWGSC revised the project plan to include the creation of a small breakwater pointing northward from the north corner of the marginal wharf using the former armour stone that had been excavated from the sandbar. See figures 5 and 6 for photos of the site upon project completion.

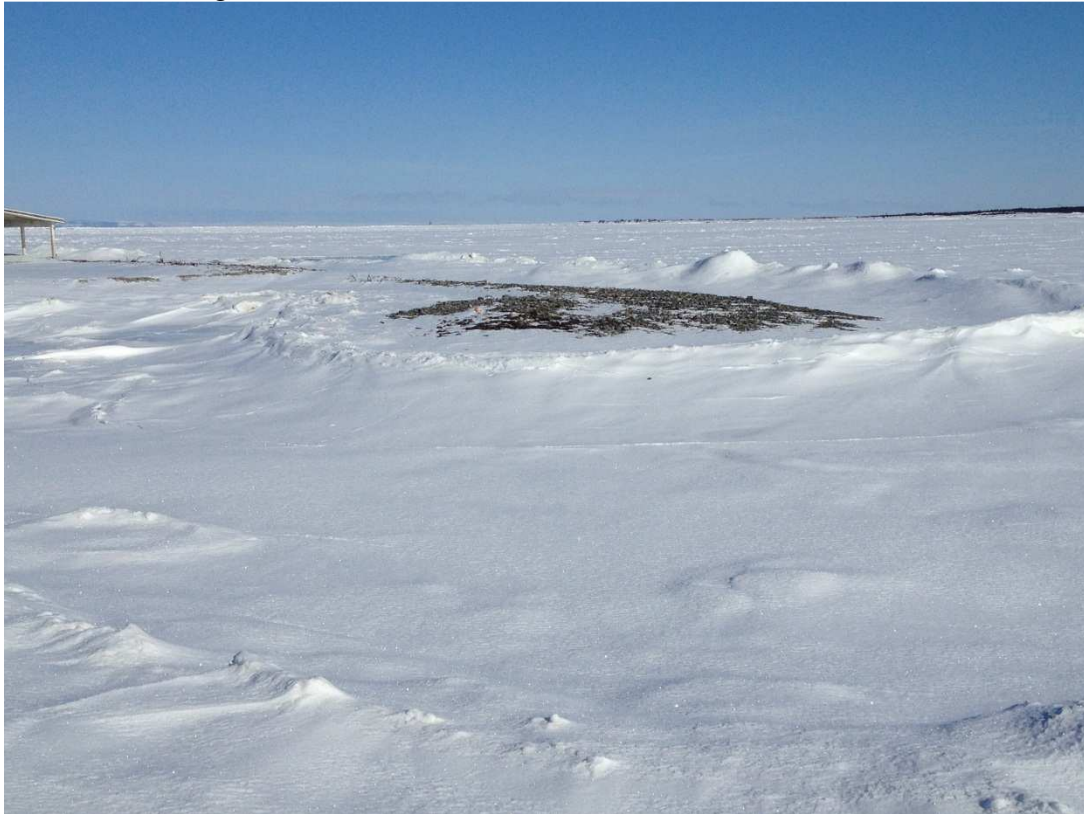
Figure 7 – Sandbar Reformation (photo courtesy of Chris Gaslard)

When contacted for comment, PWGSC stated that they had not followed up on the project and had not yet been requested to do so by DFO-SCH. A PWGSC Project Officer stated that they believed that the infilling had continued immediately after the project was completed, and would continue to do so until a groyne was constructed. The following photo (Figure 7) was taken in March of 2013, and

despite ice conditions, a noticeable sandbar can be seen to have reformed of the east corner of the embankment near the marginal wharf.

While no reports of the stationary basin or sludge responsible for creating the stench have been received since the project was completed. DFO-SCH realizes the potential for the reoccurrence of the issue and holds the potential construction of a groyne in its future plans.
