THE HERALD OF FREE ENTERPRISE TRAGEDY

Christopher Pope

Memorial University of Newfoundland
15 Dublin Road, St. John's, NL, Canada
Ccp880@mun.ca

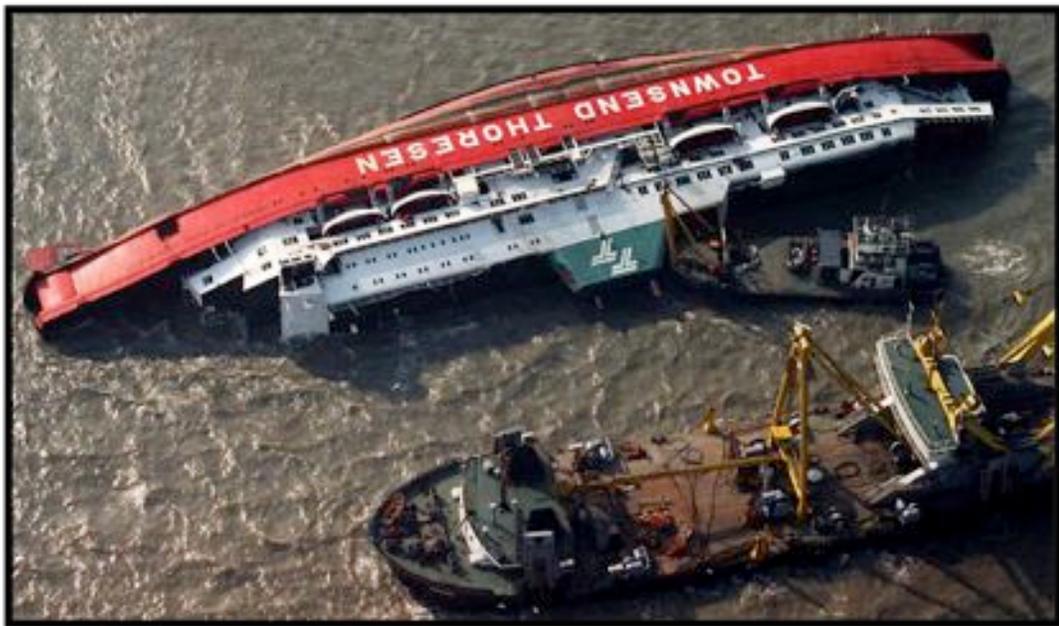
Figure 2: Resting Position

the disaster he had returned to the wheelhouse in an effort to reconcile a strained schedule. Furthermore, to make up lost time, the First Officer ordered the vessel to set sail before the bow ballast tanks had completely emptied from the previously stated unloading procedure. The ferry was steaming through the harbour with the master and deck officers keeping a close eye on the hulls bow because the nose was dipped towards the water line. Records show that as the ferry proceeded through the harbour, speeds were considerably below its capability in order to keep water from flooding over the hulls bow [2]. As the ferry exited the harbour all three engines were set to full speed and the boat forcefully accelerated to a speed of 18 knots. When the ferry reached the 18-knot mark a combination of water flooding, ship squat, dynamic sink age and an increase in bow wave height caused water to enter over the bow hull. At a speed of 18 knots it is believed, through full-scale experiments with the sister ship *Pride of Free Enterprise*, the bow hull was approximately two meters below the water level [2]. Water poured over the bow hull and through the open bow loading gate, a rapid heeling of 30 degrees to the port side followed. The vessel briefly righted itself before more water accumulated on the port side causing a slow, steady heeling that caused a partial capsizing. The vessel did not fully capsize because it came to rest on a sand bank at a heeling angle of approximately 90 ninety degrees. See Figure 2 below for a photo of the *Herald of Free Enterprise* in its final resting position.

The main reason for the capsizing of the Herald was that the loading gates were left open upon departure from the port of Zeebrugge. Human error caused this mistake to occur and when the open gates were complimented with the other circumstances created on March 6th, a catastrophe was unavoidable that evening. The assistant Bosun on duty was asleep when the call went out to indicate that the vessel had dropped her moorings and was beginning its voyage. Complimenting this mistake was the fact that the first officer at the time of the call, had returned to the wheelhouse in an attempt to speed up departure. It is surprising that this critical procedure relied solely on crewmembers communication and had limited redundancy. It was well known that if water entered the main deck than the stability would be drastically compromised. The status of the loading or unloading gates could not be physically observed from the wheelhouse therefore no form of mechanical redundancy existed that could compliment the human communication. If the loading gates had been closed before departure that evening, all the other events that took place on that voyage would not have led to a capsizing. Relying on all crewmembers to do their duty accordingly every voyage works theoretically but when dealing with a critical component such as the loading gates, redundancy should be a required asset.

The transport safety board completed a thorough investigation of this accident and made recommendations in order to address the general safety of this ferry during operation, loading as well as her life saving ability during an emergency. The primary recommendation stated that there was an obvious need for redundancy in the system responsible for ensuring the loading and unloading gates were closed before departure. The first and foremost method of redundancy for this system is to have a mechanical indicator light installed on a failsafe circuit in a visible area of the wheelhouse. This indicator light would present the status of the vehicle deck doors at all times and a log would record the status of the doors before each voyage. In addition to the main vehicle deck indicator light, an indicator light would be installed to show status of all doors penetrating the main superstructure [2]. Another safety measure brought forward by the board to help those in the wheelhouse monitor condition of the vessel was to install closed circuit televisions (CTV). These CTV's would monitor the major superstructure doors, engine room space and cargo compartments giving the wheelhouse crew the important ability to monitor cargo shifts and evaluate the ships condition.
