The Usumacinta Disaster

Chris Hanlon

Memorial University
St. John's, NL A1C 5S7, Canada
cmhanlon@mun.ca

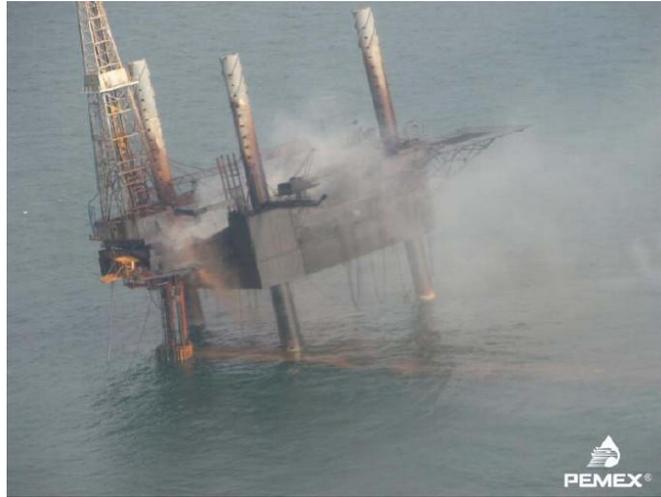
On Sunday, October 21st, 2007 the Usumacinta arrived in position next to the Kab-101 platform to finish the drilling of the Kab-103 oil well. Within three days onsite a cold front moved across the Bay of Campeche creating wind speeds up to 130 km/h and 8 meter waves. This storm caused the closure of eight separate ports in the Gulf for commercial traffic. These conditions were described by Carlos Morales, director of PEMEX's exploration and production unit as "extreme weather conditions we've never registered before." These operating conditions caused oscillations in the Usumacinta resulting in a collision of the cantilever deck of the Usumacinta and the top of the production valve tree of the Kab-101 platform, causing a leak in oil and gas at approximately 1200 hours on October 23rd, 2007.[2]

Figure 2: The Usumacinta Leaning Against the Kab-101 Platform

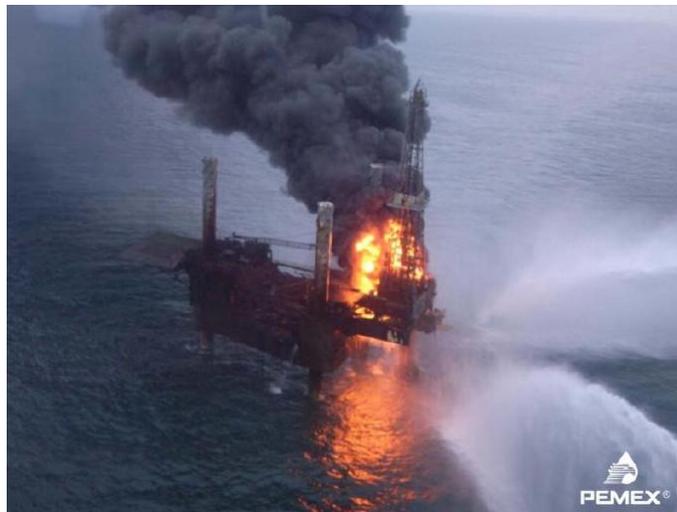
Figure 3: The First Fire on the Kab-101

Human error was also evident in causing the first fire onboard the platforms when a spark ignited a fire onboard. This fire (observed in Figure 3) luckily did not cause any injury but caused severe onboard damage. This could have been avoided by more stringent protocols for those working in such a risk-filled situation thus lowering the chance of human error causing these scenarios.

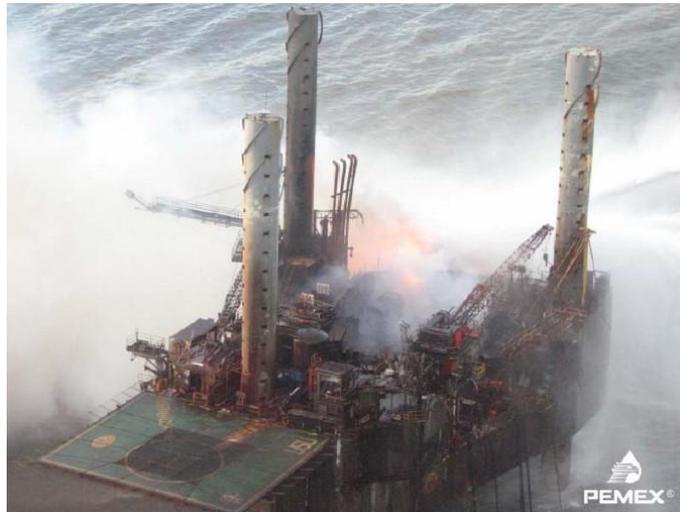
Around 1420 hours the subsea valves of wells 101 and 121 were closed by PEMEX in order to stop the leakage of oil and gas. Unfortunately the valves were damaged in the collision and some leakage continued after the safety valves were closed. This resulted in an evacuation of the 81 crew members occurred at approximately 1535. On November 13th, a spark from on-going containment work caused a significant fire to ignite on the Usumacinta observed in Figure 3. This fire was put out on November 14th at approximately 2350 hours. A second fire occurred on November 20th causing immense damage to the Usumacinta platform including the collapse of its derrick and severe damage to the cantilever deck and connecting bridge. This damage can be observed in Figure 4.

Figure 4: Collapse of the Usumacinta's Derrick and Heavy Damage Caused by the Second Fire

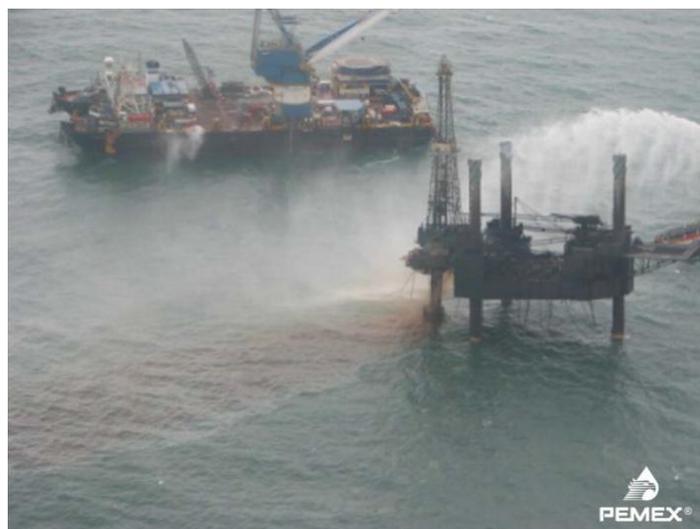
Figure 5: A View of the Spilling Oil

Control teams were sent to the Usumacinta to assist in containing the oil spillage and terminate the leakage but were severely delayed due to the rough sea conditions and the hazardous gases released in the leakage. Initially spill was estimated to leak 442 barrels of light crude a day. PEMEX estimated that approximately 40% of this spillage was evaporated. PEMEX used a variety of chemicals to recover the lost oil and successfully obtained a total of 8701 barrels.[2] PEMEX estimated however that 5000 barrels of oil were unable to be recovered. PEMEX noted however that the leakage was more gas than oil which was impossible to retain and was left to enter the environment. Additionally some spilt oil was observed to have been absorbed into beaches nearby the oil well. PEMEX reported the recovery of over 500 tons of sand with hydrocarbons that is estimated to be equivalent to 394 barrels of oil. [2]

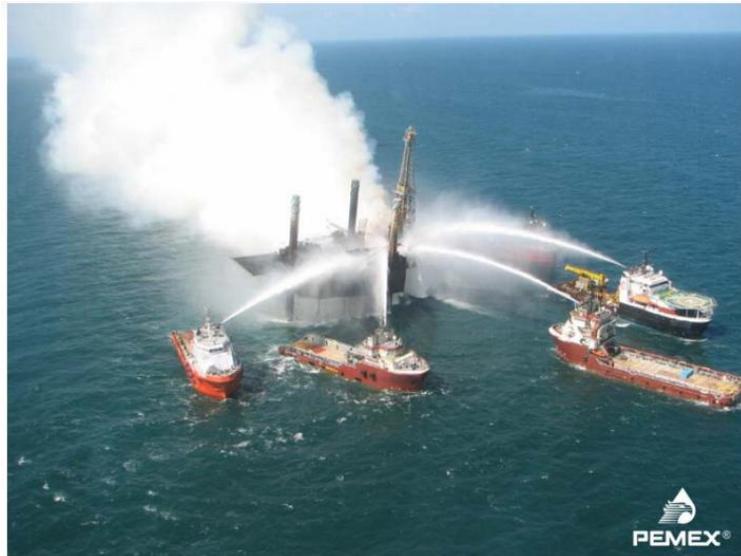
Upon the realization that the safety valves had been compromised and the evacuation had been ordered, PEMEX assigned the ship Morrison Tide and three other vessels to provide support in the case of a fire. In hindsight this was a very smart strategy on PEMEX's behalf because during the course of attempting to control the spillage two fires broke out aboard the Usumacinta. These vessels can be seen in Figure 7 extinguishing the second fire that ignited.

Figure 7: Support Vessels Extinguishing a Fire

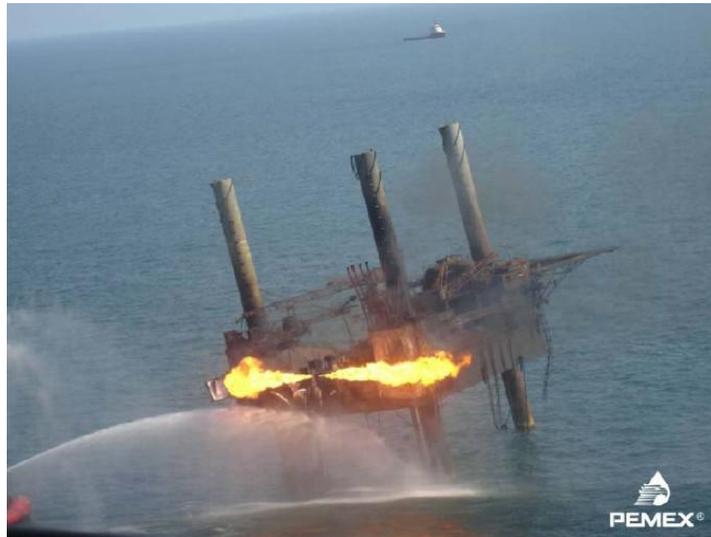
Other control work was completed in order to mitigate the risk of the situation including removal of debris from the Usumacinta, the installation of a blow-out preventer to eliminate the chance of a blow-out occurring and dramatically increasing the oil leakage. One additional risk control strategy that was put in place by PEMEX that significantly decreased the amount of oil and gas leaked from the Kab-101 was the installation of a valve that facilitated control burning. Instead of the excess oil leaking into the water it is instead burnt off and controlled by the fire support vessel to ensure no damage was incurred.

Figure 8: The Control Burning Valve in Use
