## **The Ocean Ranger Disaster**

**John Price**

Memorial University of Newfoundland  
St. John's, Newfoundland, Canada  
jdprice@mun.ca

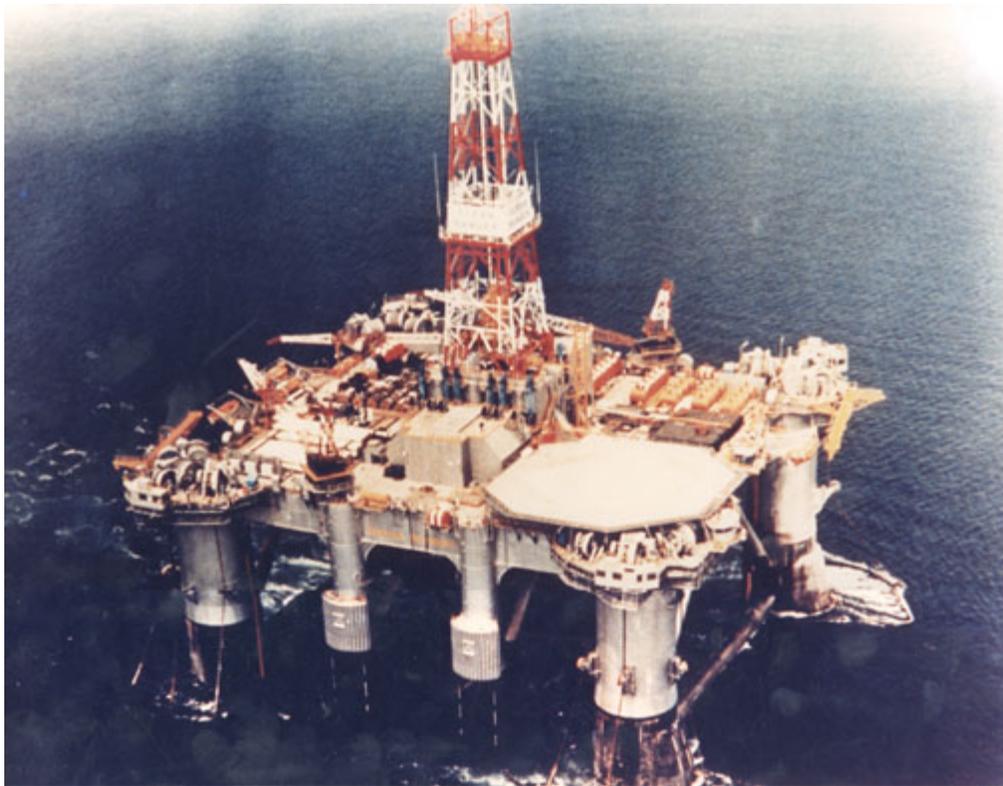
Figure 1 - MODU OCEAN RANGER [2]
