A Study of Pile Fatigue Failures in the Arabian Gulf

Leanne Stein

Memorial University of Newfoundland
St. John's, NL, A1C 5S7
lms423@mun.ca

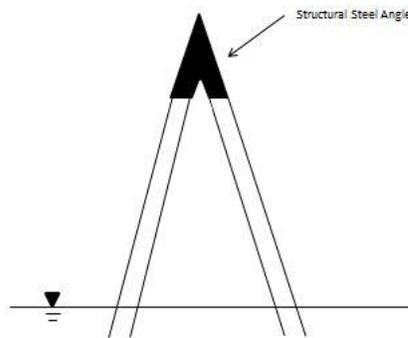
Figure 2 – Batter Piles

The force on the free piles due to the wave loading caused significant moments at the mudline. In December of 1974, a particularly large storm hit, and two days later it was discovered that two of the

piles had failed and cracked at the mudline girth butt weld. A butt weld is a weld between two parallel objects that are pushed together but do not overlap, i.e. no additional components are used. Essentially, the girth butt weld connects two lengths of hollow steel pipe pile together around the circumference. The cracked piles were removed and larger diameter piles were fitted over the existing bases.

After some observation, it was determined that the excessive moments exerted at the mudline during the storm resulted in fatigue failure of those two piles at the mudline. Further investigation showed that several other piles showed cracks at the mudline, some larger than others. This discovery triggered a more in-depth study to determine whether the piles would fail in the future and why the fatigue occurred in the first place.

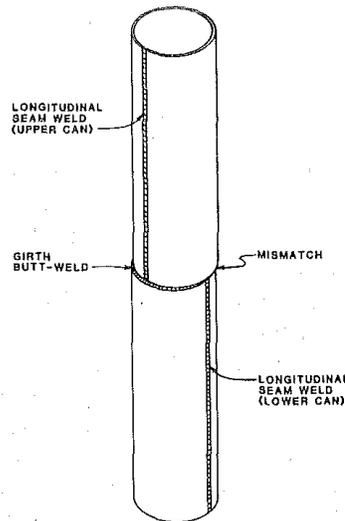
Figure 5 – Weld Mismatch

One possible cause of failure could be attributed to manufacture faults. The piles are formed by rolling sheets of steel into “cans” and welded longitudinally. These sections are then welded together using girth butt welds to achieve the desired length. Sometimes, a mismatch occurs where the longitudinal welds do not line up.

This mismatch creates a discontinuity, which interrupts bending stress patterns. As a result, it cannot deliver full curvature.

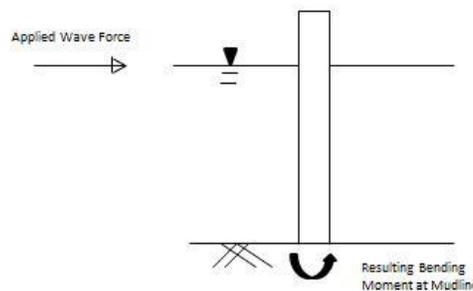
Figure 6 – Bending Stress

The next concern that had to be addressed and studied was that an undetected isolated defect could grow into a through-thickness crack. For this concern, it was required that crack propagation studies must be completed to analyse the situation. This involved the estimation of design, stresses, shear resistance, and operating conditions with the superstructure installed. With this, the expected bending stresses at the mudline could be calculated (Figure 5).

The bending stresses, based on all assumptions and estimations, were determined to be low in this case.
