MODU Ocean Express Disaster 1976

Matthew Williams

1 ABSTRACT

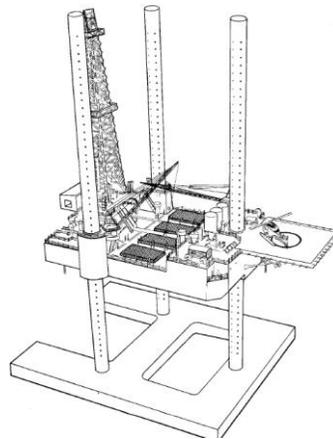
Figure 1: Sketch of Ocean Express

The platform hull is supported by three 12ft diameter cylindrical jack-up legs which rest on a steel mat that sits on the seabed. The mat has a total of 14 tanks; 6 of which are permanently flooded, 6

permanently buoyant and two cooling tanks. During transportation the mat is jacked up to a 2ft separation between it and the hull.
