The Ocean Ranger Disaster

Brent Marsh

Memorial University of Newfoundland
St. John's, NL, Canada
b.marsh@mun.ca

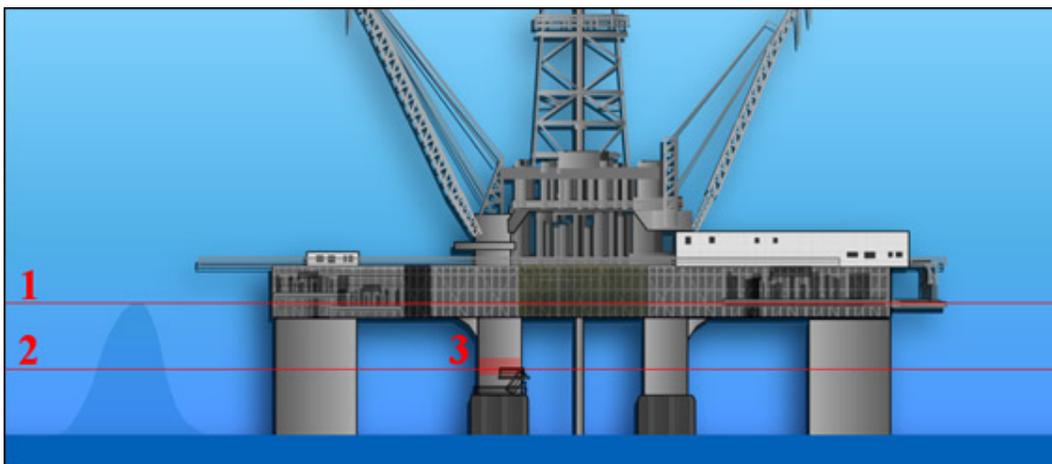
Figure 3: Ballast Control Room (3)

The ballast control room, shown in Figure 3, was designed to be a waterproof area, as exposure to water could have catastrophic consequences within a very short period of time. However, there was a breakable port light in the control room. In addition to that, the console had no protection such as insulation. When the port light broke, The Ocean Ranger was left completely vulnerable. Figure 4 shows how the disaster could have started. Later studies showed that the glass did not meet either the industry standard for strength or the thickness shown on the rig's plans. In addition to that, the control console was the only way for operators to know if valves were opened or closed. If there had been an alternate system, the crew would have better understood the situation even after the console had been destroyed. Had they been able to understand what was happening, they may have been able to react in a more efficient way [7].

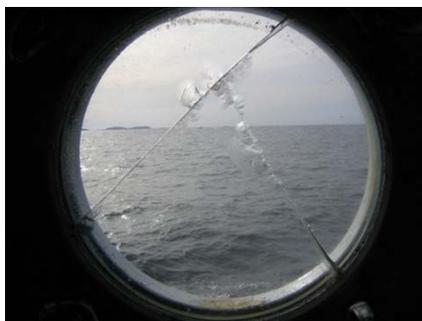
Figure 4: Porthole

- The port hole in the ballast control room was broken by an uncharacteristically strong (rogue) wave, causing water to flood the room.
- Due to the flooding, the ballast control ceased to function.
- There was then a loss of power. It is not certain if the crew instigated this in attempts to repair the situation or if the storm was the culprit.
- Due to the water build-up, the rig began to tilt forward.
- This caused the forward chain lockers located in the forward corner support columns to fill with water, causing the rig to tilt even more dangerously.
- The water needed to be evacuated; however, the pumps were not able to be used due to the tilted position of the rig.
- The ballast control panel should have been able to be operated manually. None of the employees present were trained to do so.
