THE OCEAN RANGER DISASTER

JoAnne Dodd

Memorial University of Newfoundland
St. John's, NL, Canada
joanne.dodd@mun.ca

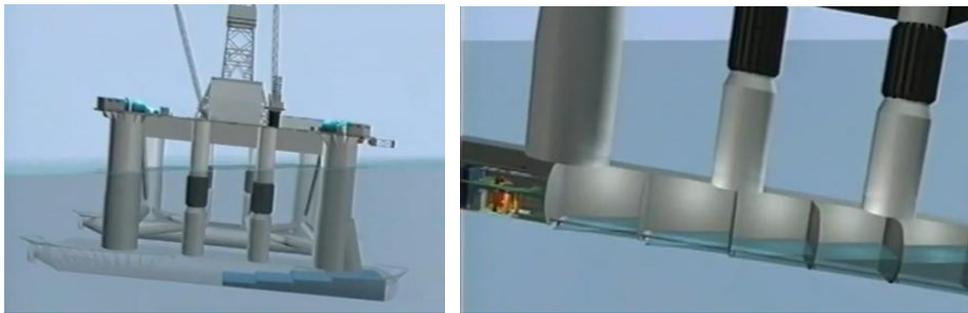
The crew noticed that something was wrong so they cut the power again, but it was too late. This caused the Ocean Ranger to be 10 degrees off balance. The only course of action was to pump out the ballast tanks, but such a problem was not included in the engineering design of the rig, and therefore there was no way to drain the tanks. Instead pumps were only installed in the rear of the pontoon and they would only work if the rig was level and at this point the rig was listing forward.[6]

Figure 4: Simulated illustration of the Ocean Ranger 10 degrees off balance (left) and the pump at the rear of the pontoon (right) [6]

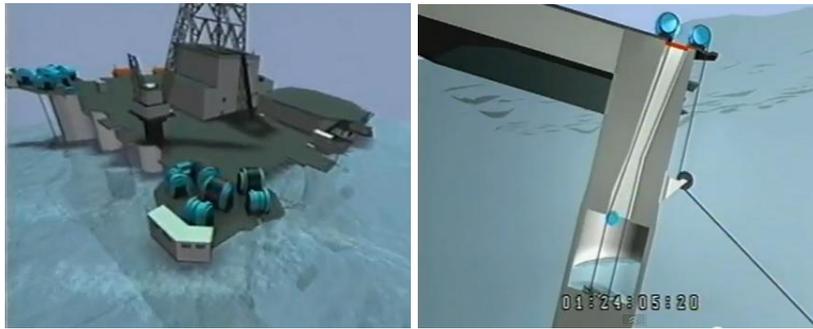
It is unclear exactly what may have happened in this point in time. However, there are three likely scenarios. 1) Due to the electrical malfunction, the valves remained open and the rig resumed a forward list. 2) The group in the ballast control room tried to manually override the system and get the valves to close but they had no formal training to do so and cause the valves to remain open (human error). 3) A combination of human error and equipment malfunction. It is clear however, that the Ocean Ranger somehow resumed a forward list which was increased when water filled the six foot chain lockers. These chain lockers had no cover and began to fill with water causing the rig to become more off level until it finally capsized.[6]

Figure 5: Simulated illustration of the forward list (left) and chain lockers filling with water (right) [6]

Two major design flaws are that of the chain lockers and the ballast control room. It can be said that these components were not designed for failure but rather for ideal conditions. The chain lockers were designed to allow significant distance between the locker opening and the ocean surface assuming the rig had an even keel. This would have been an ideal condition. However, with 12 anchors in total, not even their weight would keep the rig stable once harsh waves and high winds created a major cyclone. A hatch over the deep pockets would have prevented this mode of failure if the designers had taken these circumstances into account.[8]
