Petrobras P-36 Accident Rio de Janeiro, Brazil

Sara Whelan

Memorial University of Newfoundland
St. John's, NL, Canada
sara.t.whelan@mun.ca

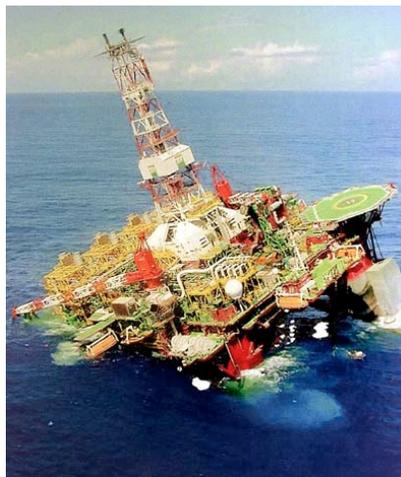
Figure 2: Petrobras P-36 at 16deg Tilt

Upon detection of the explosion two fire-fighting pumps were activated leading to further flooding, due to the rupture of the sea water pipe. Failure of airtight dampers, allowed for water to invade the aft starboard pontoon rooms, including the pump room, water injection room and the access tunnel. With the inflow of water causing the failure of seawater pumps the hole that was created in the explosion was allowed to remain open. As a result this allowed the platform's list to continuously grow eventually reaching an incline of sixteen degrees.

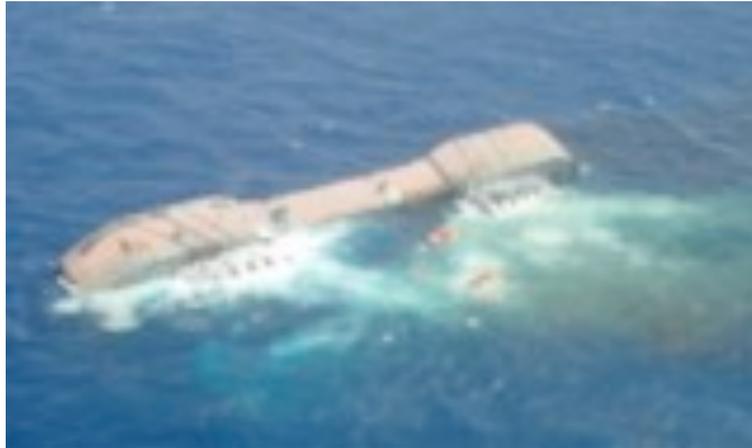
Figure 3: Petrobras P-36, March 20, 2001 (Capsized)

The submersion of the chain locker pipe at the main deck level led to down flooding in the platform. Continued slow flooding of the starboard aft pontoon continued till the deck box compartments and central caisson was completely flooded causing the platform to capsize and sink.

In an attempt to prevent loss of the platform 4,100 tons of nitrogen was pumped into the flooded compartments in an attempt to discharge an approximately 15% of the estimated 7 million litres of flooded seawater. The structure eventually capsized on March 20th, 2001.
