## **Bell Island Lighthouse Relocation Project**

**Amanda Curnew**

Memorial University of Newfoundland

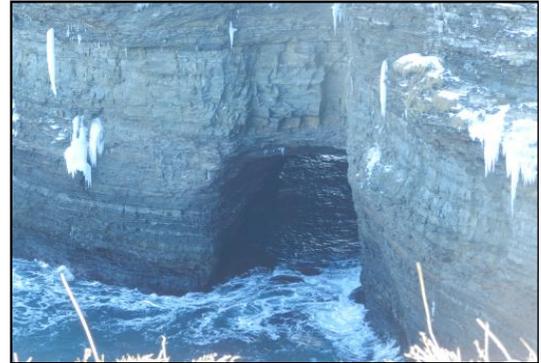
Figure 4: Cave Through Eastern Head

Through AMEC's investigation they identified various geological faults. A cave has been eroded along one fault in particular, completely through Eastern Head, as illustrated in Figure 4. It is believed that the cliff slopes are eroding at a fast rate. AMEC reported that the "slopes in the area are practically bare of any organic growth, which indicates fresh rock is continuously being exposed." The sea caves located beneath the cliffs would be stable if erosion was not a factor. The roof spans and their conditions were not known; therefore, further work would be required to monitor their condition and prevent collapse.

Based on the AMEC report, it was concluded that further information was required to determine the rate of erosion and slope stability. During the study, erosion due to constant wave action was estimated to be 4 to 5 cm per year. AMEC also concluded that the site was in "no imminent danger"; however, rapidity of erosion of the sea cliffs would eventually place the infrastructure in jeopardy. It was recommended that a topographic survey be completed for the site and surrounding cliffs to monitor the movement or loss of material. As well, precise information to determine the location of the caves and their dimensions would assist with determining the rate of erosion. A recommendation to relocate the lightkeeper's residence was suggested; however, the lighthouse could remain where it was until obvious erosion impeded access to the lighthouse, at which point relocation would then be considered. [4] Lastly, when asked if Coast Guard personnel were in any immediate danger, the reply was that a future risk assessment would be required to determine the level of risk to employees and the public. [3]

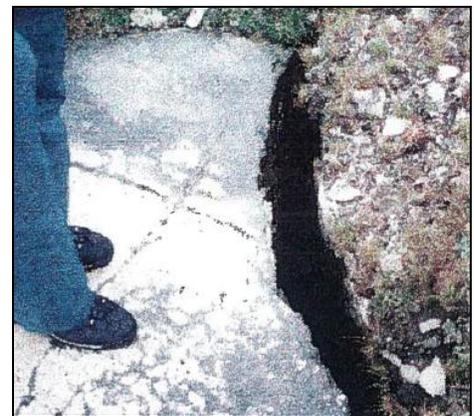
Figure 5: Tension Crack 1 to 3 m From Cliff [5]

Similar to what was noted in the AMEC report, C-CORE also mentioned that the lighthouse area is strongly affected by erosion, with evidence of numerous tension cracks that had developed, as shown in Figure 5. During fieldwork along the coast, C-CORE was able to confirm the average erosional rate of 4 to 5 cm per year estimated in the AMEC report, based on observations and mapping of existing tension cracks.

Overall, C-CORE’s study indicated that the lightkeeper’s residence was located in a relatively unsafe zone, affected by the presence of active erosion at sea level and extensively weathered rock onshore. It was recommended that the residence be relocated to a position on the land where potential risk would be reduced to an appropriate level. As well, consideration to relocate the access road and electric poles further inland was recommended if the lightkeeper’s residence was to remain in the present location. Visual observations of nearby surficial slides were observed and it was concluded that the area of the access road was relatively unsafe. [5]
