Arnold's Cove Wharf Rehabilitation

Kallan Fitzgerald
Memorial University
St. John's, NL, Canada
z45kwgf@mun.ca

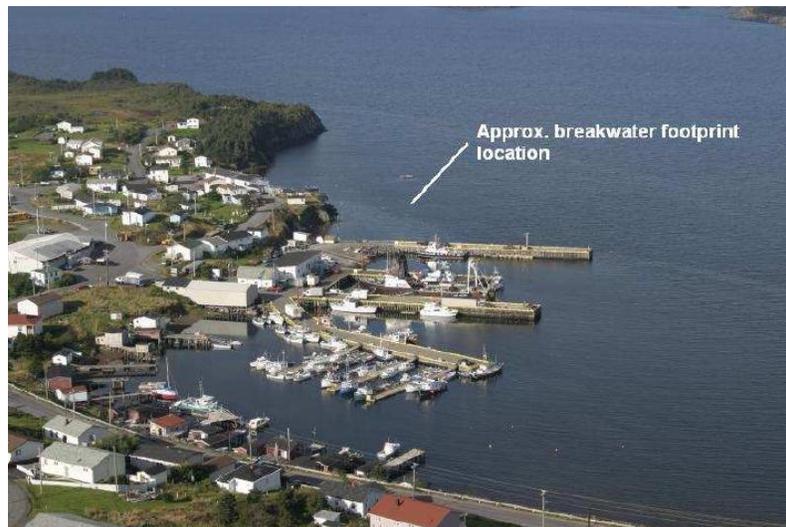
Findings: Finger pier #404 was originally acting as a breakwater structure, reducing the harsh wave action for the remaining structures in the harbour. However, the seaward side of this structure was completely exposed to storm undertow conditions and the wharf was not of an adequate length to completely shield the entire harbour [4]. These inadequacies caused unsafe berthage areas where vessels were unable to dock, thus limiting the efficiency of the existing harbour structures [4].

Figure 5: Aerial photograph depicting the approximate location of the proposed breakwater [4].

Recommendation: From these findings, the recommendation came to construct a rubblemound breakwater outside of the existing structures. The rubblemound breakwater will provide shelter to the existing wharves and safe access to all berthage areas [4]. The proposed breakwater will measure

approximately 160m by 45m and will require 24,785 m³ of core stone, 6,930 m³ of filter stone and 10,005 m³ of armour stone [4]. As an addition, the area between the existing breakwater wharf and the new breakwater will be infilled using material such as core and filterstone to develop a laydown / service area [4]. See the figure below for a representation of the proposed breakwater structure.

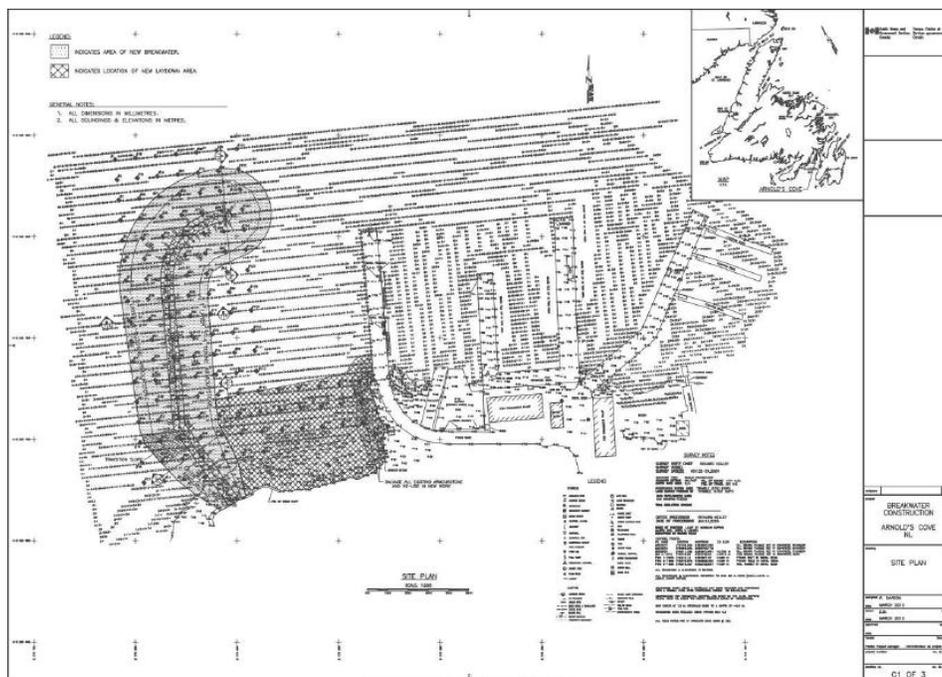
Figure 6: Plan view of proposed rubblemound breakwater and laydown area [4].
