The Sea Gem: A Story of Material Failure

Lisa Burke

Memorial University

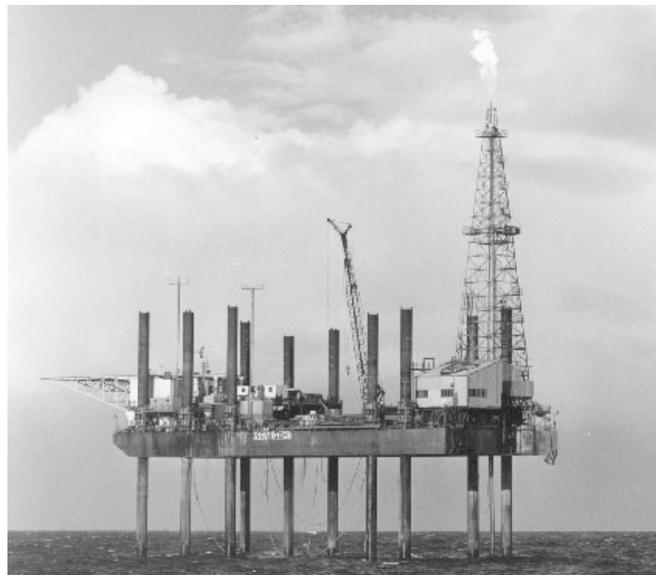
Figure 2: The Sea Gem drilling platform [2]

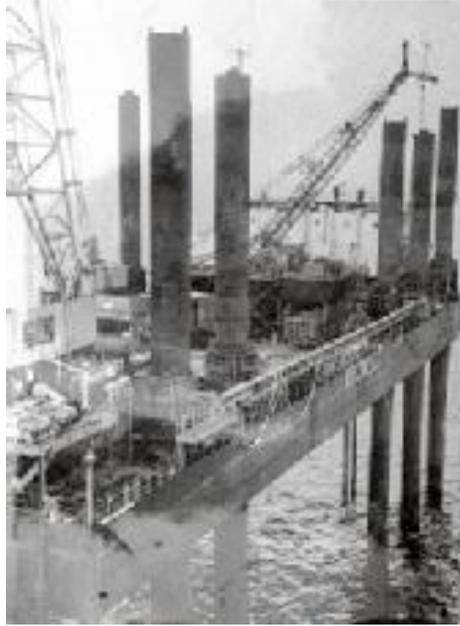
On December 27, a jacking operation began in order to lower the Sea Gem by 3.05 meters. This was in preparation for movement of the rig to another location. At the time, the wind was north northwest, wave heights were less than 3 meters and the air temperature was 3°C. When the procedure began, forward jacks moved as expected, but intermediate moved less than forward and aftermost ones were unresponsive. Operators could not specify the reason for failure through visual inspection. There was no report of unusual, alarming or emergency situation by the operator. The senior operator decided to recover original position by releasing air from the forward jack cylinders. However, this manoeuvre caused the portside jacks to slip. Shortly after, the forward starboard legs collapsed beneath the water line, leaving the hull at an uneven keel. The torsion of the fall caused a 4-inch wide tear in the hull, which filled with water and the vessel sank.

Figure 3: The Sea Gem collapsed [4]

In the investigation after the wreckage, it was determined by a tribunal that “some part of the suspension system linking the hull to the legs must have failed. The evidence...points irresistibly to tie-bars as having been, by their failure, the initiators of the collapse. It was that failure that introduced incalculable dynamic forces, which, once set in motion, led cumulatively to the disintegration of the whole structure.”

- 5 legs in the wreckage had missing or broken tie-bars;
- Tie-bars retrieved by divers were examined and had fractures that were brittle and originated from severe notches, weld defects and fatigue cracks;
- Conditions at the time of the accident were conducive to brittle fracture;
- The jacks were still intact and in compression state in the wreckage (therefore not the cause of collapse).

The tribunal investigating the case made several recommendations, even though it was not expressly required. A notch tough steel with a Charpy value of 47.5 Newton-meters at 0°C should be specified for tie-bars which are to be used in winter conditions in the North Sea. Also, consideration should be given to provide shelter from the weather for jacks in these conditions.
