Replacing The Gull Rock And Little Bay Islands Navigational Sites

Stephen Lundrigan

Memorial University of Newfoundland
St. John's, NL, Canada
s.lundrigan@mun.ca

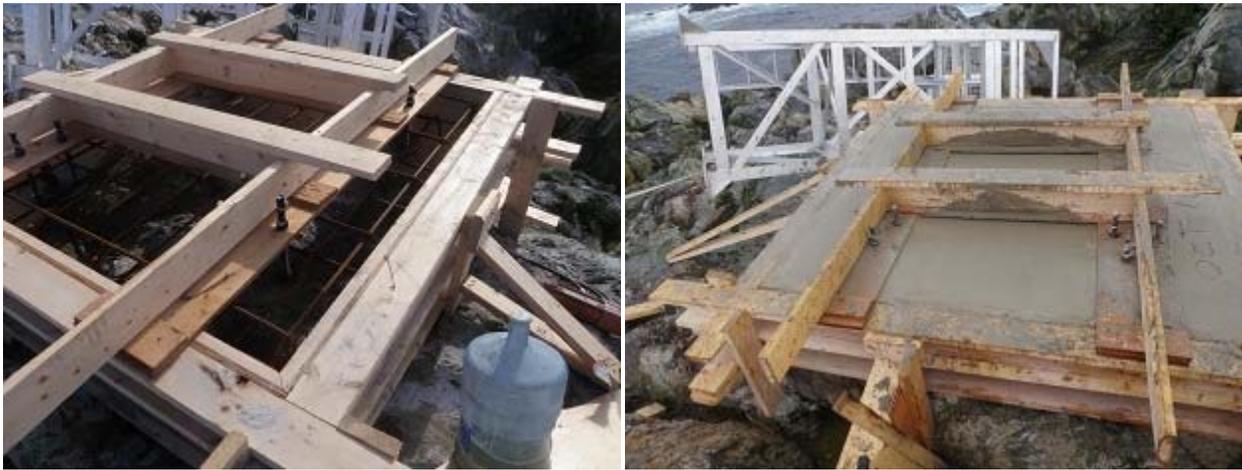
Figure 3: Formwork for Concrete Block Before and After Pouring (Source: Canadian Coast Guard)

A gravity based tower design was the optimal choice for Gull Rock. Gravity based structures involve installing a large concrete block for the tower foundation rather than depending on the rock surface present. First a large hole was blasted in order to build the formwork. Within the formwork, reinforced steel was placed and twelve high strength metal rods were strategically set vertically for tower connections. Concrete was then poured, leaving only a portion of the connection rods above the surface. After a period of seven days, the formwork was removed and the tower was placed.

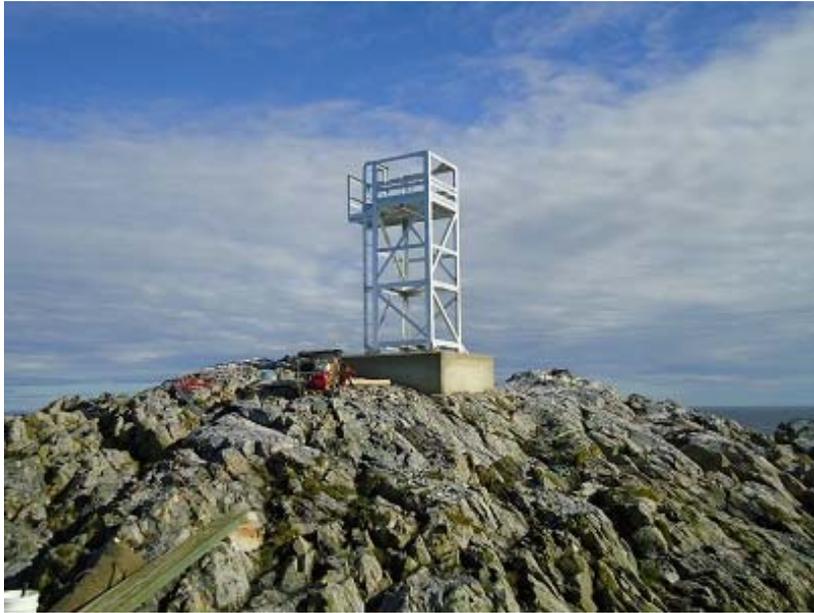
The original tower present on Gull Rock was a rock-anchored design. This design involves the connection of a high strength guy wire from the tower to a concrete filled hole drilled in the rock surface. Guy wires are connected in at least four directions to sustain all forces.

Upon inspection of the failure it was noted that the rock surface was not able to withstand the forces created at the guy wire base, fractured and ultimately created no resistance to the tower being washed away.

Figure 4: Implemented Gravity Based Tower at Gull Rock (Source: Canadian Coast Guard)

High strength grout was then placed on the concrete surface at the base of each rod and the new aluminum tower was crane lifted into place. High strength stainless steel bolts were then attached to keep the tower from any uplift forces. After the quick dry grout sets within an hour the tower was fully installed.

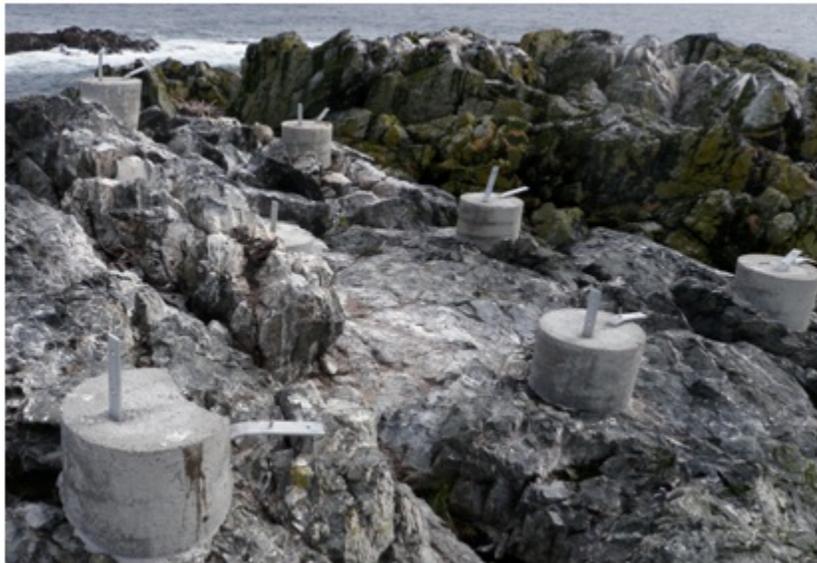
Shortly after the inspection of the sites began it was realized that the helicopter pads were not braced properly in the horizontal direction. It was determined that the failure occurred gradually over time and the storm waves were the final mode of failure.

Figure 5: Horizontal Failure of Helicopter Pad Supports (Source: Canadian Coast Guard)

The new helicopter pads were a focal point of the replacement operation as the helipad was a brand new design. It had to support both lateral and vertical forces without relying on the original rock for assistance. The final design was implemented in the following phases:

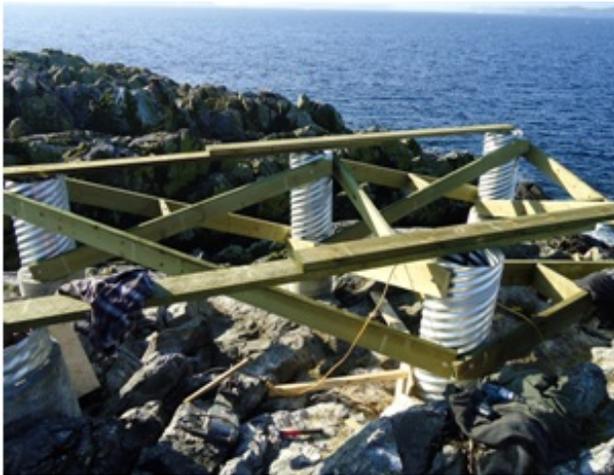
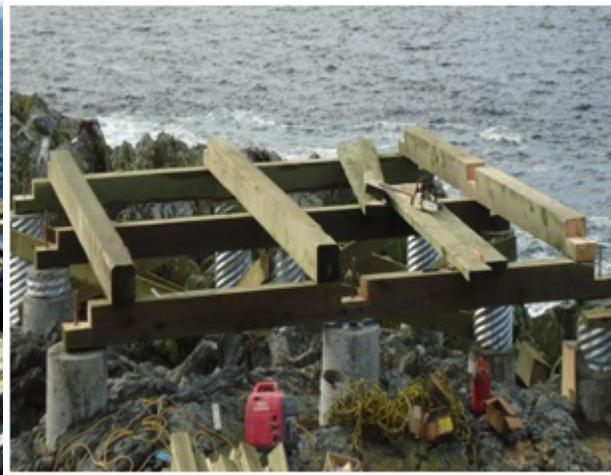
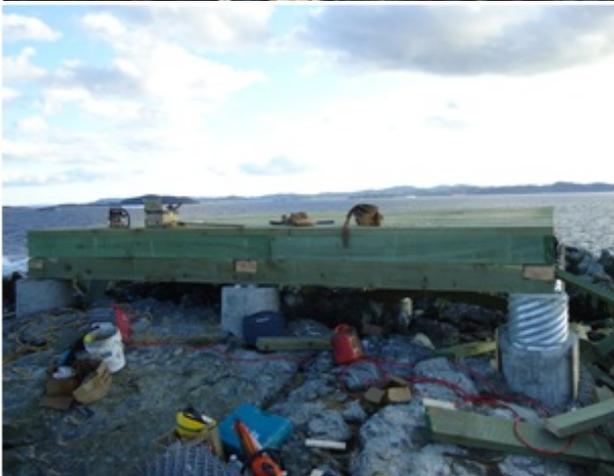
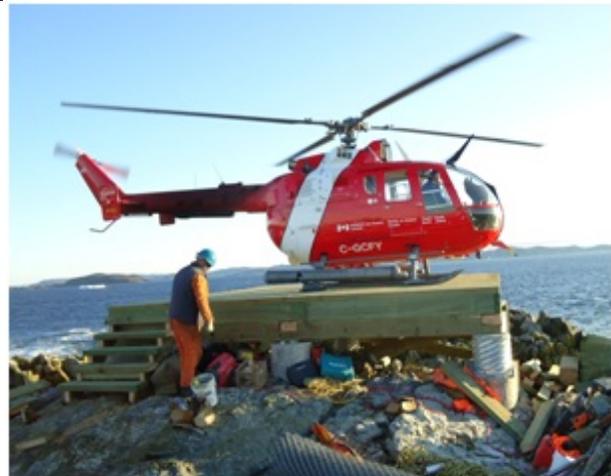
Figure 6: Figures illustrating the Phases of the Helicopter Pad Replacement (Source: Canadian Coast Guard)

Phase 1: Nine holes, 24'' in diameter were busted out from the rock surface. Each hole was equipped with a circular steel bracing. Within the bracing a large steel rod was placed through the center and two metal plates were installed at the edges, both held in place by stirrups. Concrete was poured inside the bracing and cast for seven days.

Phase 2: 2'' x 4'' timber was attached from each steel braced pier to the next closest pier on two separate sides by drilling a hole through the timber and the steel bracing then connecting the two to the previously installed metal plates with large stainless steel bolts. This mode prevents the pad from failing in the horizontal direction.

Phase 3: A square frame was created out of 4'' x 4'' timber on the tops of each pier. The frame was supported by six 2'' x 4'' cross bracings (long direction vertical). Upon the square frame a second layer of 4'' x 4'' timber was installed and 2'' x 4'' timber was then placed across the second frame creating the top deck of the helicopter pads (long direction horizontal). The timber is supported by metal bracing at each edge completing the helicopter pad installation.
