Deepwater Horizon

Josh Winsor

Memorial University of Newfoundland
230 Elizabeth Avenue, St. John's NL, Canada
D24j1w@mun.ca

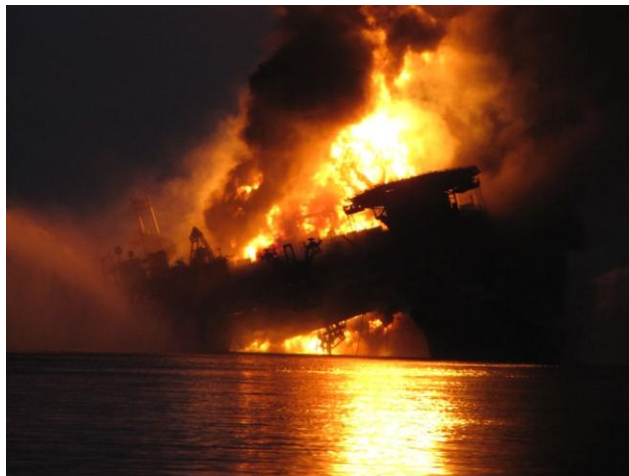
The fire on the vessel after the explosions was fuelled with endless amounts of hydrocarbons from the blown out well. The fire pumps could not be operated to supply water to the fire main and sprinkler system because of the total electrical power loss from the second explosion. With the fire being endlessly fuelled and the firefighting systems onboard not functioning, the firefighting team decided it was futile to attempt to fight the fire. The Master of the Deepwater Horizon decided to abandon ship. [1]

Figure 2: Deepwater Horizon engulfed in flames

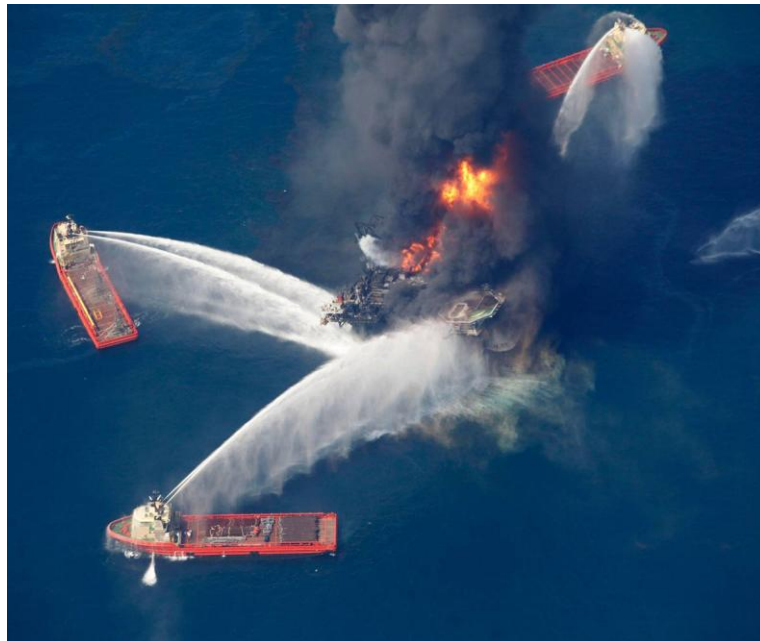
Eleven different vessels arrived to the scene following two days after the explosions to fight the fire, using fire monitors, as seen in figure 4. SMIT Salvage Americas, a contractor with Transocean, eventually took charge of the firefight. Deepwater Horizon lost stability and became submerged in the ocean most likely because of the abundant volume of water being applied to the fire. The vessel finally sank at 10:26am on April 22nd, 2010.

Figure 3: Supply ships attempting to firefight the blaze of Deepwater Horizon

The exact cause of the vessel's loss of stability and sinking cannot be determined but it has been concluded to be caused by or a combination of the following factors:

- Damage to the MODU from the explosions and fire
- Accumulation of water from firefighting efforts in downflooding points on the vessel
- Migration of water within the MODU watertight barriers that were damaged, poorly maintained, or left open by crew at the time of evacuation

It is essential to maintain watertight integrity on the MODU if it is to be saved during a firefighting mission. There must be a coordinated plan among vessels fighting the fire to make sure water is not injected into downflooding points or areas on deck which will decrease the stability. The stability of the vessel should be given in real time to an observer(s) on shore thus weights on the vessel are known when fighting a fire.

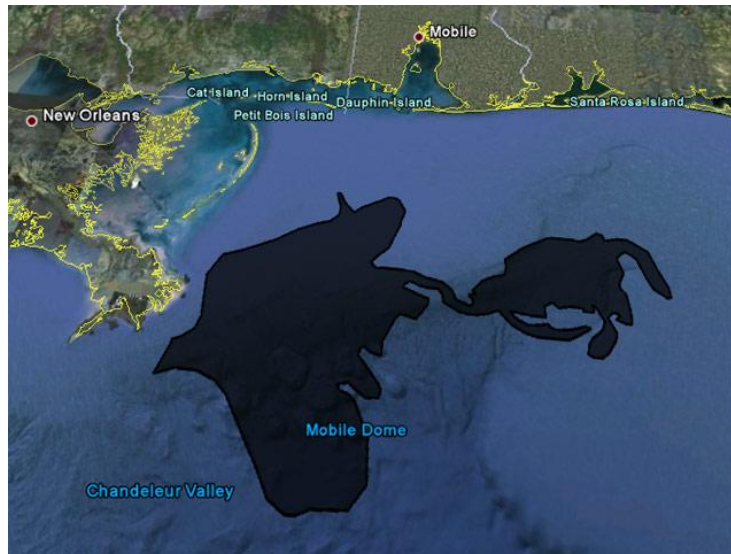
An astonishingly amount of hydrocarbons leaked into the Gulf of Mexico for over 87 days from the well until it was successfully capped. It is estimated that over 4.9 million barrels of crude oil were displaced into the ocean. Figure 5 shows the area of the Gulf that was covered by the oil spill. It is considered the worst environmental disaster in U.S. History.

Figure 4: The Estimated Oil Spill Area
