## **Mumbai High North Platform Disaster**

**Jenine Daley**

### **ABSTRACT**

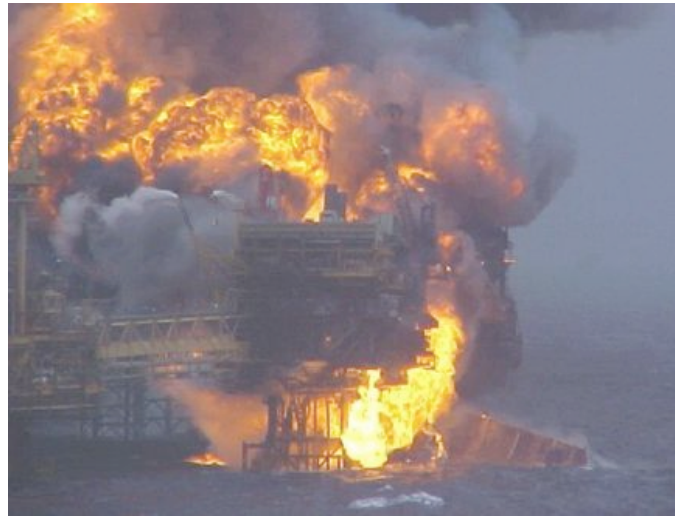
thrusters were unable to compensate. The helideck of the vessel struck one or more of the export gas-lift risers in the SW region of MHN at approximately 1605hrs [5]. The resulting gas leak ignited and flames spread rapidly to adjacent risers with no fire protection. Emergency shutdown valves did not contain the flow of hydrocarbons in several of the longer risers, some of which reached 12km in length. Explosions occurred and the fire escalated extremely quickly. The duration of the immensely destructive fire was just under two hours and it engulfed the entirety of MHN and MHF, as illustrated in Figure 3 below. Nearby platforms and jack-ups working in the area were severely affected by heat radiation.

Figure 3: MHN Platform Engulfed in Flames (July 25th 2005) [5]

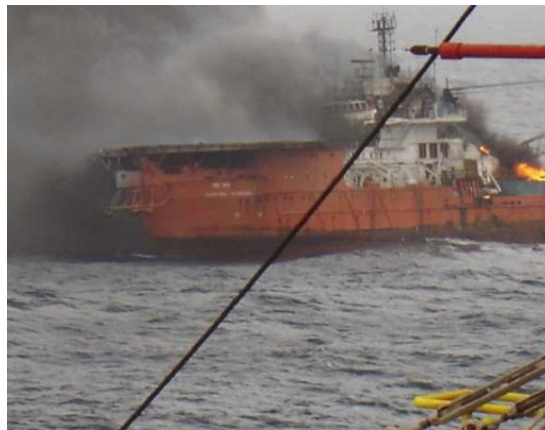
Figure 4: MSV Samundra Suraksha post-collision with MHN [1]
