*PT-13: Coastal and Ocean Engineering ENGI.8751 Undergraduate Student Forum  
Faculty of Engineering and Applied Science, Memorial University, St. John's, NL, Canada March, 2013*

## **Climate Change – Placentia Flood Wall**

**Alana Earle**

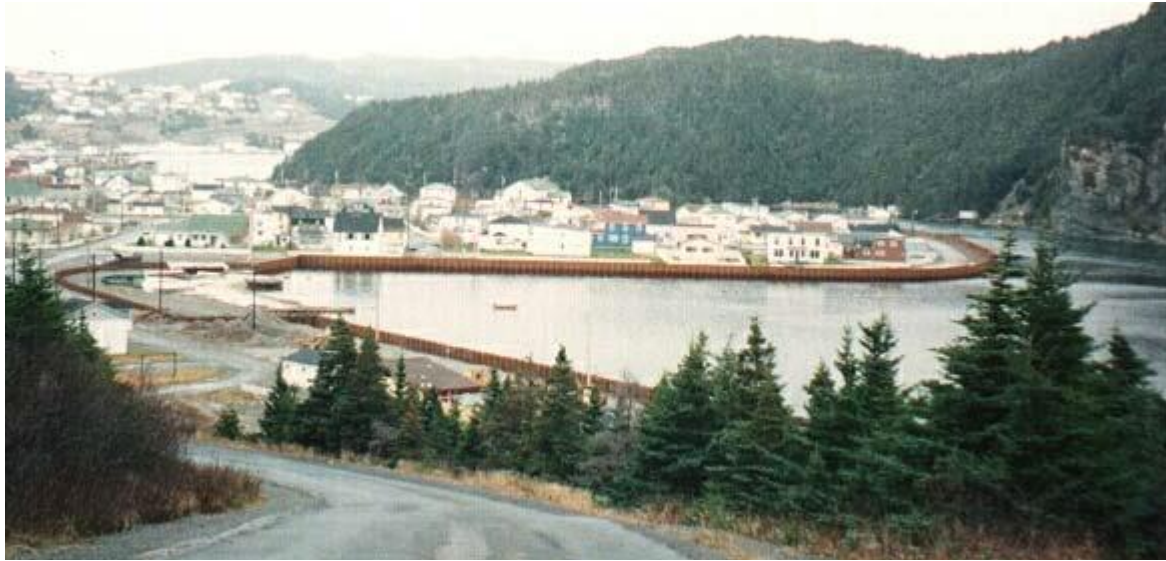
Figure 3: Steel Sheet Pile Wall around Southeast Side of the Community

The flood wall in Placentia was constructed of steel sheet pile with a top elevation of 2.2 m. each of the steel sheet piles of the wall were driven into the water and founded good soil and bedrock material. The wall runs parallel to and between the main beach and a road on the downtown peninsula portion of the town. Aesthetically designed, the wall includes a publicly accessible and maintained boardwalk spanning the top. Since the flood wall construction there has been no flooding to date. However, the flood plain is still considered at risk to flooding and with potentially more severe storms in the near future due to climate change this infrastructure must be assessed to determine its flood resisting ability.

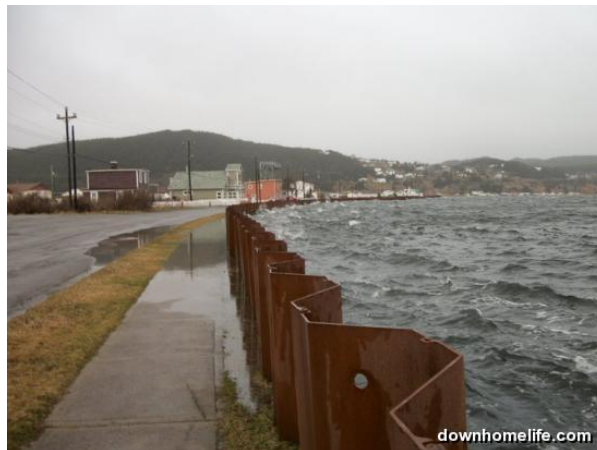
Figure 4: Sheet Pile Flood Wall in Placentia on December 23, 2010

At the time of the design of the floodwall, in 1992, a typical high tide was 1.2m under calm conditions. Luckily for residences, aside from occasional spay, there has been no waves which have overtopped the wall. However, since construction, the wall has experience continuous wave and tide action and has not under gone any regular maintenance. Therefore it is possible that corrosion to the wall may compromise its flood protection ability. Also, the height of the wall may not be sufficient for higher tides and storm induced waves. The figure below illustrates an example of high tide acting on the sheet pile flood wall in Placentia on December 23, 2010. From the location of the wall where the waves strike and the puddle of water landside of the wall it is noted that under current conditions the wall is barely high enough to prevent flooding.

It is noted that from the results above, the steel sheet pile wall, located 2.2 m above sea level elevation of 0 m, in Placentia is not able to withstand neither the current nor predicted climate events for the sea level elevation during a storm surge. However, due to the presence of the lift bridge, incoming waves tend to loose significant energy and therefore high waves reaching the flood wall are not of concern but instead high tides resulting from these tides are of concern. As previously stated, the high tide was approximately 1.2 m during the time of construction and is assumed to have increased since then therefore the next step in the assessment should be to be to monitor the current wave heights which are reaching the wall and determine a prediction based on the information gathered.

The assessment undertaken by the committee also revealed that little to no maintenance has been performed on the steel sheet pile wall in Placentia since it had been constructed in the early 1990s. Discoloration of the wall in areas of dry and wet splash zone can be visually observed upon inspection.

Also, due to the discoloration noted on the wall, the steel should be tested by means of anode testing to determine the extent of corrosion in order to assure the resisting capacity of the wall. Corrosion is a serious concern of steel structures in marine environments because if unmonitored it can lead to sudden unexpected failure and thus flooding of the town. To date the town has neglected to perform any monitoring or maintenance to the wall. It is recommended that the wall be monitored on a regular basis by competent individuals to assure its integrity is not compromised.
