2013: Coastal and Ocean Engineering ENGI.8751 Undergraduate Student Forum  
Faculty of Engineering and Applied Science, Memorial University, St. John's, NL, Canada, March, 2013

Paper Code. 2013-Clark

## **The Sir Ambrose Shea Lift Bridge Replacement Project In Placentia, Newfoundland**

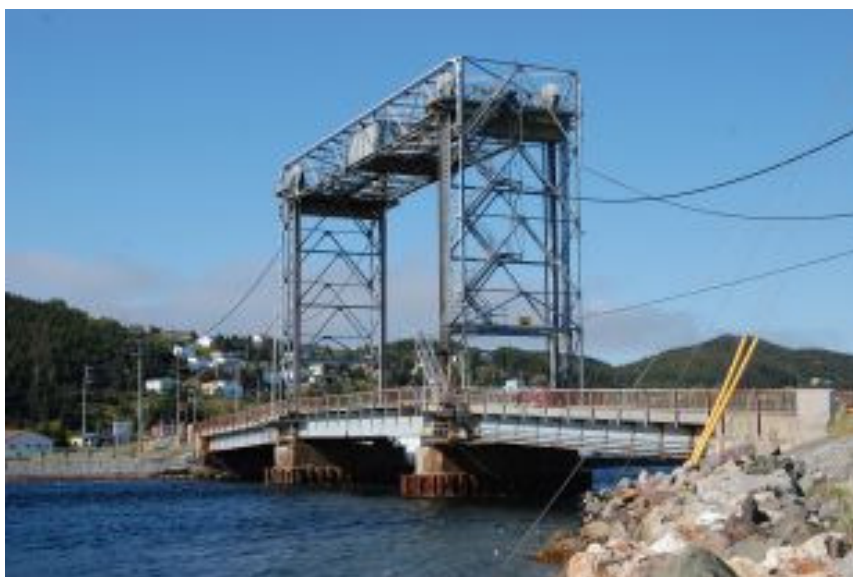
Figure 2: The Existing Sir Ambrose Shea Lift Bridge [5]

Access to the harbours inland is through a 100 foot passageway commonly referred to as 'the gut'. This causeway, poses a logistical problem in transportation as it creates a disconnect between the towns of Jerseyside and Placentia, but it is also necessary to maintain vessel traffic to the harbours beyond Placentia. There were many ideas implemented to solve this problem over the decades, including ferries and makeshift moveable bridges, but it was not until 1961 that the problem was solved with the completion of the Sir Ambrose Shea lift bridge (see picture on next page). This bridge could accommodate both vessel and vehicular traffic. [4]

Recently, this historic bridge has reached its lifespan and is deteriorating to the point where weight restrictions for vehicular traffic were imposed. Temporary repairs to the bridge were carried out in the past year and the entire bridge is slated to be replaced. There have been challenges however in obtaining a contractor to construct the bridge at a reasonable cost with the sole bid in 2012 coming in at \$19.25 million over budget. However, the contract for the bridge replacement was finally awarded on March 5, 2013 to HJ O'Connell Construction Limited for \$40.6 million. [6]

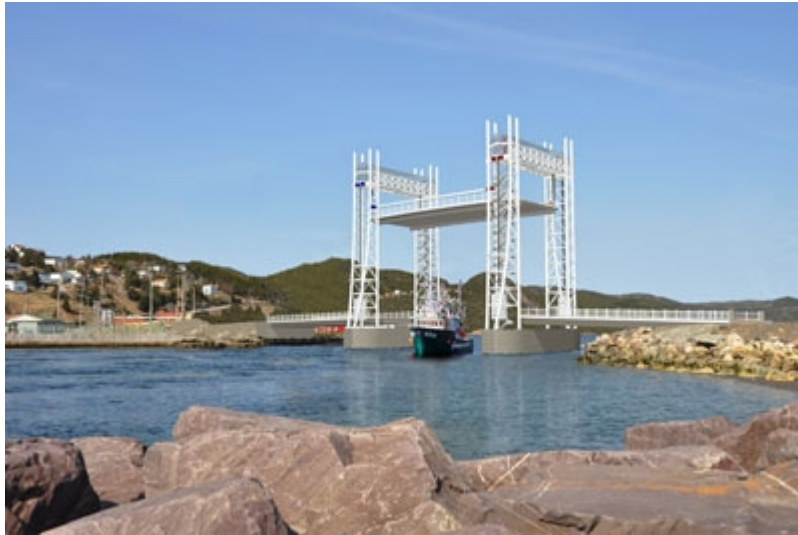
The architectural and detailed design for the new lift bridge has been completed by Delcan and is pictured in Figure 6. Delcan states that has improved function and durability by “recognizing that simple and conventional operating systems bring the highest degree of reliability and minimize maintenance” and “determining that these conventional systems, both mechanical and electrical, should form the basis of the bridge design as much as practical”. Delcan in their design, were cognizant to minimize the exposure to the elements by having closed structural sections, and enclosing mechanical machinery. [12]

Figure 6: New Bridge Design
