Coastal Erosion in Daniel's Harbour

Michael Luther

Memorial University of Newfoundland
St. John's, NL, Canada
Michael.luther@mun.ca

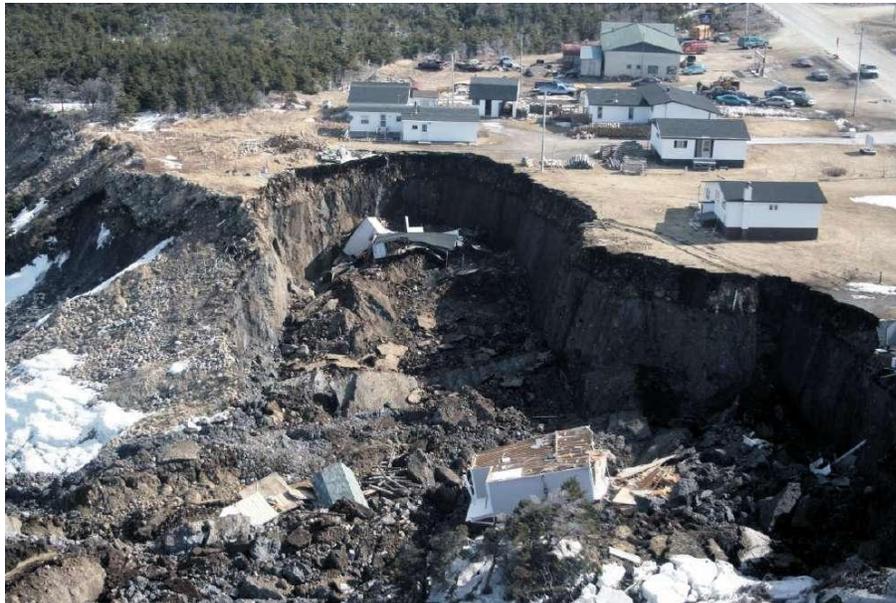
Figure 1: Results of Landslide in 2007

Throughout its history Daniel's Harbour has been protected by a natural rock wall. However due to the combination of coastal erosion of the weak underlying soil and the increased soil saturation within the area this protection has come into question in recent years. As a result of these contributing factors, devastating landslides have occurred along the coastal cliffs located on the northern side of the town. Occurrences in 2006, 07, 08 and again in 09 have lead to the destruction and abandonment of homes and other nearby structures, temporary and permanent re-routing of roads, and other inconveniences for the town's residents.

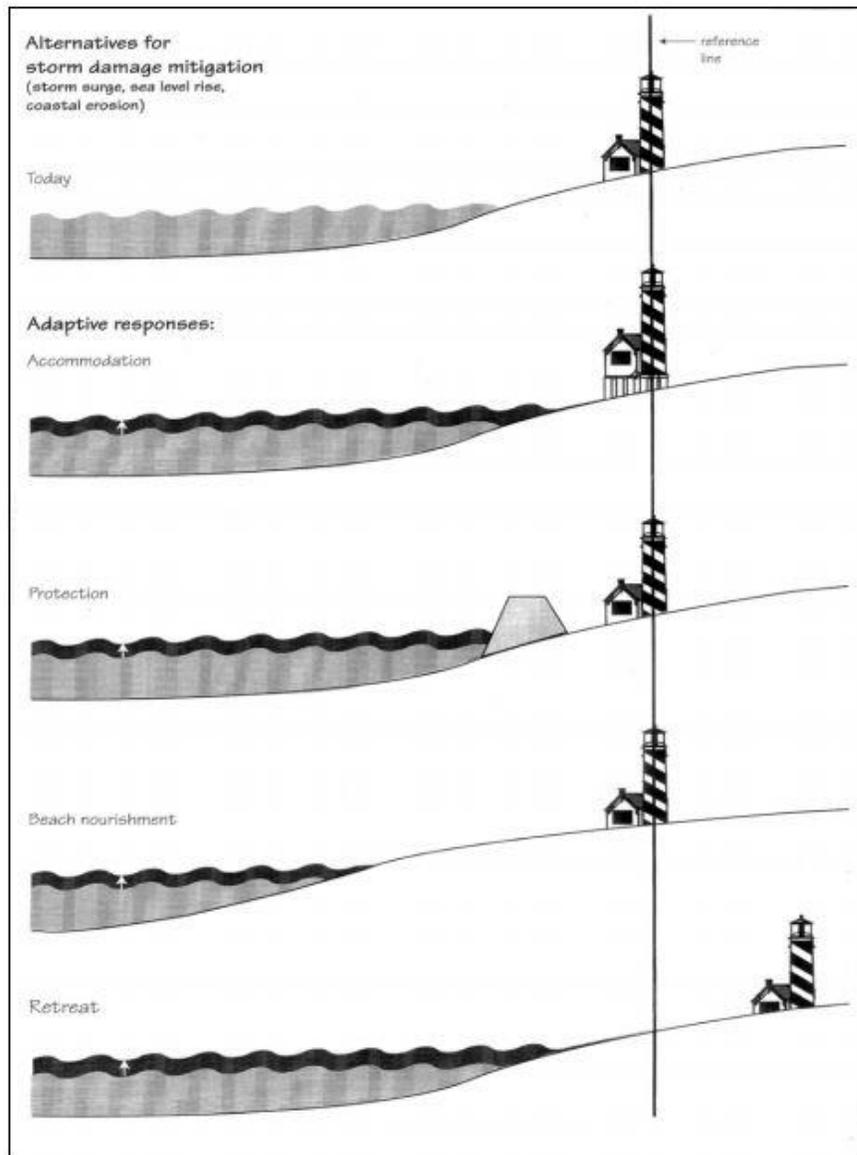
Figure 3: Alternatives for Shoreline Protection

The first of the three basic approaches is the protection method. This category is divided according to the application of hard or soft engineered solutions to defend vulnerable areas, especially populated centres, economic activities and natural resources [7]. In terms of hard engineered solutions, this method is further subdivided into armouring and shoreline stabilization. Armouring refers to the use of seawalls, bulkheads, and protective revetments for cliffs and dikes. The relatively high cost for this approach is justified when erosion is effecting low areas of substantial human investment. Shoreline stabilization on the other hand uses near shore breakwaters, groins, and wetlands to moderate coastal sediment transport processes to reduce the local erosion rate [1]. An application of this approach is used when erosion due to diminished sediment supply becomes a major problem. The design used for this approach must be carefully constructed as improper functionality has lead to adverse environmental impacts. Soft protection provides coastal defence by supplementing natural processes and enhancing the natural environments. These solutions are reversible in most cases and allow a wider range of coastal management options to be available to future generations [7]. An example of this approach is beach nourishment. This requires loose sediment material to be place on the beach as underwater mounds. Due to several constraints that exist with many projects, this soft alternative solution has become the most common alternative for shore protection [1].

By elevating structures, flood proofing, zoning restrictions, changing land use or construction methods one can accommodate or adapt to coastal erosion or flooding of an area. The adaption or accommodation approach is the next method in the management and engineering response for shore protection [1]. Although it is rather difficult to achieve due to the permanent nature of erosion, accommodation can be achieved by physically changing an environment to accommodate increased erosion through advanced planning. The two most common examples of this method are the alteration of zoning and building codes to reduce damage cause by erosion. For example building codes could specify the minimum floor elevations or modified drainage that should be used in areas where surging water and high winds are expected.

The final of the three alternatives for shoreline protection is the retreat method. This method requires advanced planning and acceptance that some coastal zones may be lost due to erosion. One example of this application is the enforcing of setback limits. Limiting construction close to the shoreline can reduce the risk of erosion by limiting the potential effects [7]. This is usually enforced by Governmental efforts through the acquisition of land, land-use restrictions, prohibiting reconstruction of property damaged by storms and reduction of subsidies and incentives for development in vulnerable areas. Another option included within the retreat method is the allowing of developments on the condition that it will be abandoned if necessary. This option gives the government a more limited role and forces liability on the investors [8].

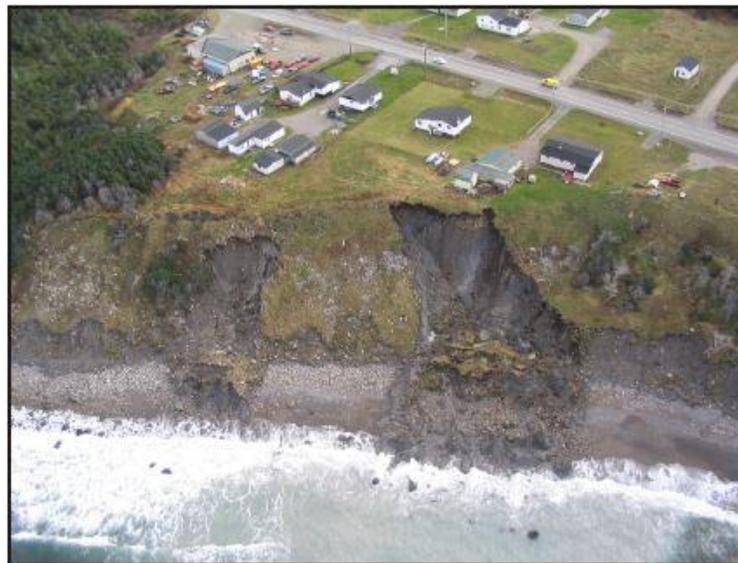
Figure 4: 2006 Landslide in Daniel's Harbour

At 7:30 am on October 20, 2006 the first of a series of landslides took place on the coastal cliffs on the northern side of the town of Daniel's Harbour. The volume of the material that was involved was estimated at 20 – 30,000 cubic metres covering an approximate area of 1000 square metres, with the closest structure within 10 metres from the top of the slope. The cliffs in the area consisted of unconsolidated material and no significant rainfall had been recorded in the area prior to the landslide. A relatively large percentage of the material fell into the ocean and further landslides occurred over the days that followed leading to the evacuation of properties in the surrounding areas [2].

The first landslide in 2006 served notice to the members of the Daniel's Harbour community of the potential risks that existed due in large part to the combination of coastal erosion and the weak underlying clay that existed in the area. This potential for disaster was confirmed shortly after, when a second landslide struck in April of 2007. In this instance, the slides took place over a five day period

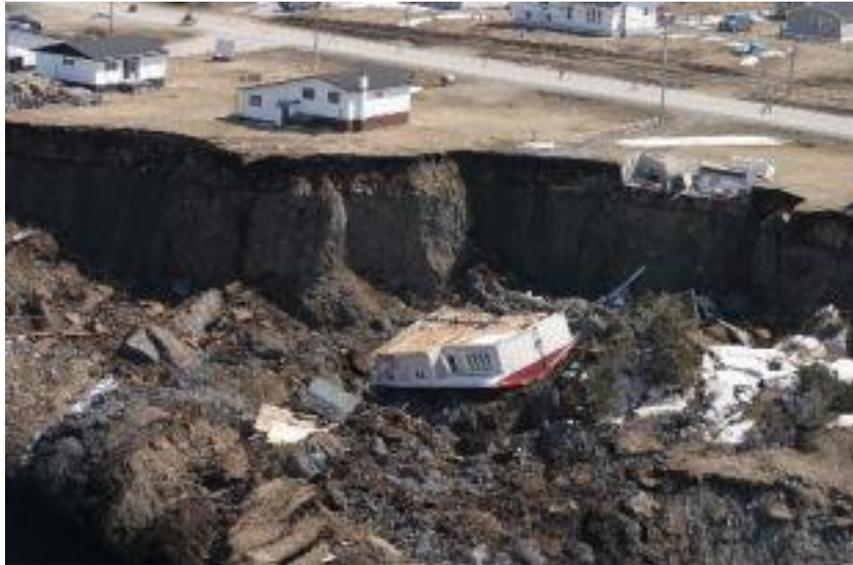
Figure 5: House which Topped over following the 2007 Landslide

and resulted in the loss of one home and several outbuildings, evacuation of seven houses and the temporary re-routing of the Northern Peninsula Highway. When finished, the landslide of 2007 involved a much greater area than the previous slide of 2006 [2]. This slide covered an area of approximately 5250 square metres, spanning 105 metres wide and extending 50 metres inland. It was characterized by a 15-20 metre vertical face and its debris was a combination of natural material from the eroded cliff face and the remnants of buildings and associated debris [5].

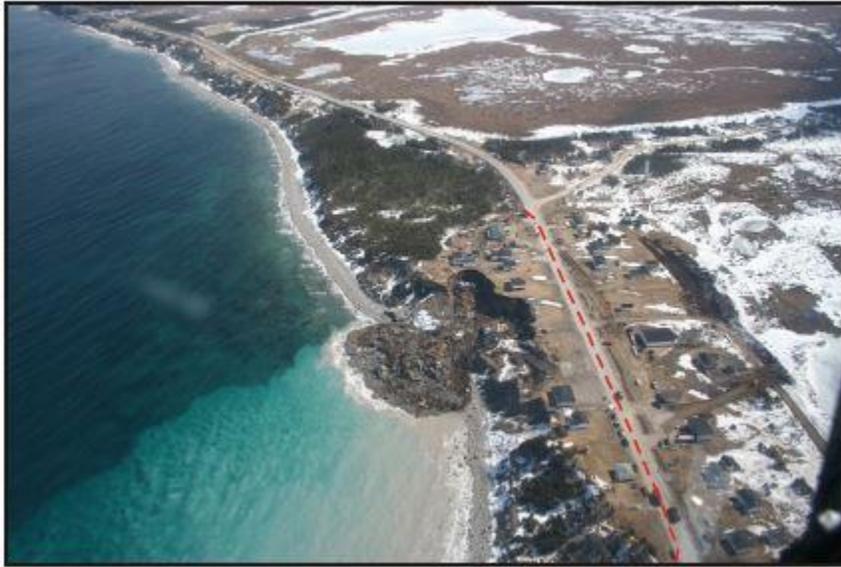
Figure 6: Location of the Landslide Hazard Zone

Following the events of the 2007 landslides that struck Daniel's Harbour a preliminary analysis of the area was completed by the Department of Natural Resources. Within this analysis the history of the area, geotechnical conditions and effects of the landslides that occurred in 2006 and 07 were taken into consideration. Due to the severity of the landslides and the unpredictability of future events it was recommended that all properties currently located west of the present highway be immediately designated as unfit for occupation. The area to the west of the dotted line in the figure below was designated as a Landslide Hazard Area and that no further development would be permitted within its boundaries. A more detail site investigation was also recommended for completion in hopes of determining all the factors that contributed to the landslides occurrences [5].

In the months that followed, further investigation was conducted into the existing conditions at Daniel's Harbour. As a result, safety zones that had been enforced on the area following the preliminary analysis were extended to include an additional 23 properties from the 10 previously impacted when the zones were first established.

In Daniel's Harbour the landslides of 2007 alone, resulted in \$6.5 million in claims to the Federal Government under the Disaster Financial Assistance Arrangements Program. However, since the establishment of the Landslide Hazard Area and other prevention techniques, the disastrous effects of the landslides that followed have been greatly reduced.
