*PT-YR: Coastal and Ocean Engineering ENGI.8751 Undergraduate Student Forum
Faculty of Engineering and Applied Science, Memorial University, St. John's, NL, Canada March, 2013*

Paper Code. (PT-2013 - Roberts)

The Study of Coastal Erosion on the Happisburgh Coast

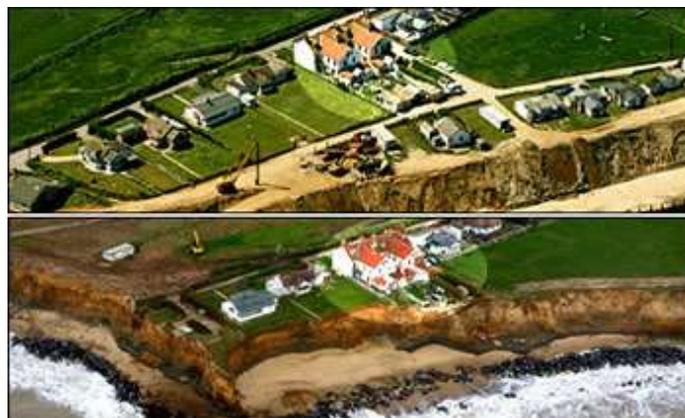
In the past the village of Happisburgh was once a safe and secure distance from the coast line of the Norfolk County, however more recently is under the danger of coastal erosion. While homes were previously 20 feet or more from the coast, currently they rest on the edge of the land waiting to collapse. In the past the village was actually separated from the coastline by the parish of Whimpwell, however the area has long since been eroded away. The last land of this medieval village was recorded to be in the late 1100's and the name Whimpwell is used for multiple streets in the town of Happisburgh. During the years of 1600-1850, it was discovered that the parish had lost 820ft of land due to the erosion and climate change. The coastline is being rapidly eroded at 39ft per year and more property is at risk of being swept into the ocean (Figure 2).

Figure 2: Erosion of the coastline in Happisburgh

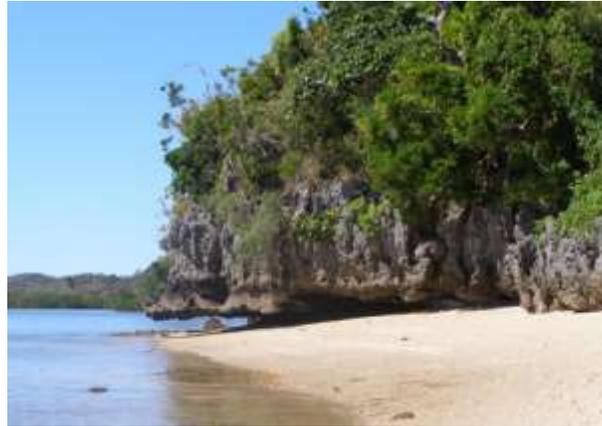
In many cases coastlines can also be susceptible to corruptions which often occur when materials with low pH chemically erode material with a high pH. This can be an issue for cliff which contain limestone because it reacts with the waters pH level easily. This reaction is again increased by high wave action because the reacted material is carried away leaving more limestone exposed (Figure 4). Seawater can also erode rock quicker because when the water seeps into existing cracks the liquid evaporates causing the salt to crystalize and expand.

Figure 4: Corroded limestone.

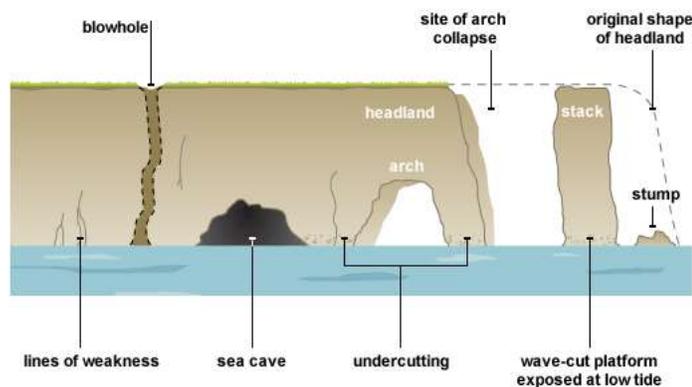
The final type of erosion is hydraulic action, which occurs when waves break onto the walls of cliffs. When the waves hit the rock it traps a large amount of air and forces it into the existing cracks in the wall. This causes a large amount of pressure inside the cracks which can break away pieces of the rock. Once the wave moves away from the cliff face, the air suddenly escapes the crack causing miniature decompression which weakens the rock. Overtime this hydraulic action can cause the side of the cliff to collapse if enough erosion occurs. A dramatic land formation that can occur due to hydraulic action is the stack (Figure 5).

Figure 5: Hydraulic action creating a stack.

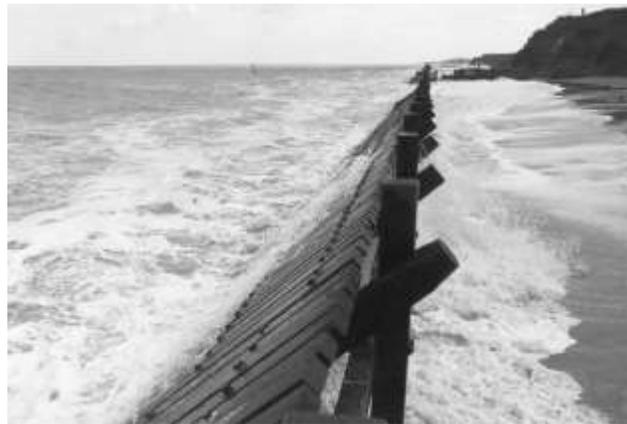
While the eroding coastal has been a problem for the Happisburgh area for hundreds of years, it was not until the North Sea flood in 1953 that the population started to think of solutions. However, even with the growing concern of losing the entire village, little has been done to fix this problem in the long term. In the years between 1959 and 1961 the first defence against the ocean was constructed, which consisted of timber revetments which were placed along a mile of the coastline (Figure 6). This solution tends to have a low life expectancy, between 5-30 years, but is also a cheap and publically acceptable way to battle erosion. Unfortunately, timber revetments are more effective in areas that only periodically deal with heavy wave action. Therefore, due to the constant battery of the waves and other elements the timber defences began to fail in the 80's and a new solution was required.

Figure 6: Happisburgh timber revetments.

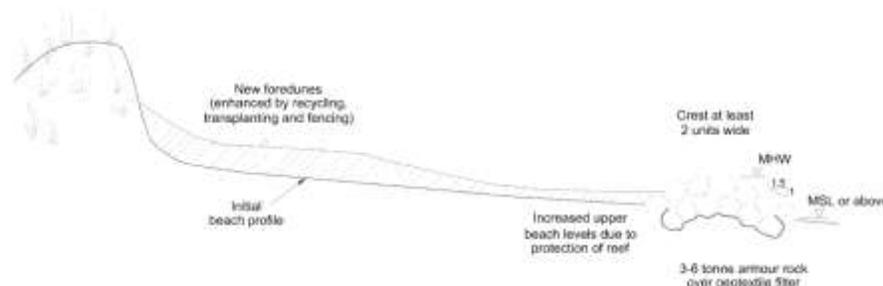
The next solution proposed by the village was to install manmade reefs off the coast to try and lessen the impact of waves onshore. Manmade reefs are commonly made by equipment or ships that are out of commission or damaged at sea but can also be made from debris or concrete (Figure 7). This system has a much longer life expectancy than the timber revetments, sometimes having an unlimited life span. While they can be more effective in normal wave conditions, however they can be less effective in storm surge conditions. Another benefit of the manmade reef is that it creates new intertidal habitat and only mildly disrupts natural processes. Some negative aspects of this solution are that reefs can be quite expensive depending on the size of the area that needs to be protected, and can cause treacherous areas for those navigating on the water. Happisburgh had thousands of tons of rock placed on their coastline in 1992, but they were only mildly successful. The first four reefs that were installed were placed too far apart so the land exposed between them is eroding away, while the remaining barriers only slow the process slightly. There was also debate following the installation of these reefs if the cost and benefits were worth the process.

Figure 7: Manmade reef diagram.

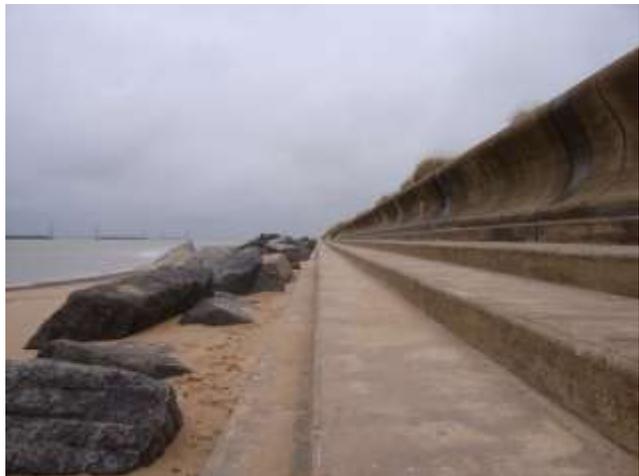
The final preventive action that Happisburgh has taken to prevent the further eroding of the coastline was to create a concrete wall which protects the agriculture land next to their beach (Figure 8). Concrete walls used to avert coastal erosion are known as sea walls or impermeable revetments. This preventive measure is often used when an area of high value is being threatened by wave action. In the case of Happisburgh, the agricultural land may not be valued quite as high as the wall that was constructed but it was an important aspect of the community. Seawalls are used to absorb the impact of waves along a smooth and often sloped face to distribute the energy. They must be able to withstand the uplift and pressure of storms to resist failing where natural processes can be completely disrupted. While the construction cost of a concrete wall is quite high the maintenance can be low. However, continuous eroding can cause structural failure if not monitored. The seawall installed in Happisburgh was successful in slowing down the erosion of the coast, however it is now over 50 years old and the government has decided that the cost of maintaining it is not worth it. The wall will be allowed to deteriorate and eventually fail, potentially allowing the farmland to fall into the ocean.

Figure 8: Concrete seawall located in Happisburgh
