Shoring Design For Pier 27 On The Shorelines Of Toronto, Ontario

Aaron Shaffer

Memorial University of Newfoundland
St. John's, NL, Canada
ajshaffer@mun.ca

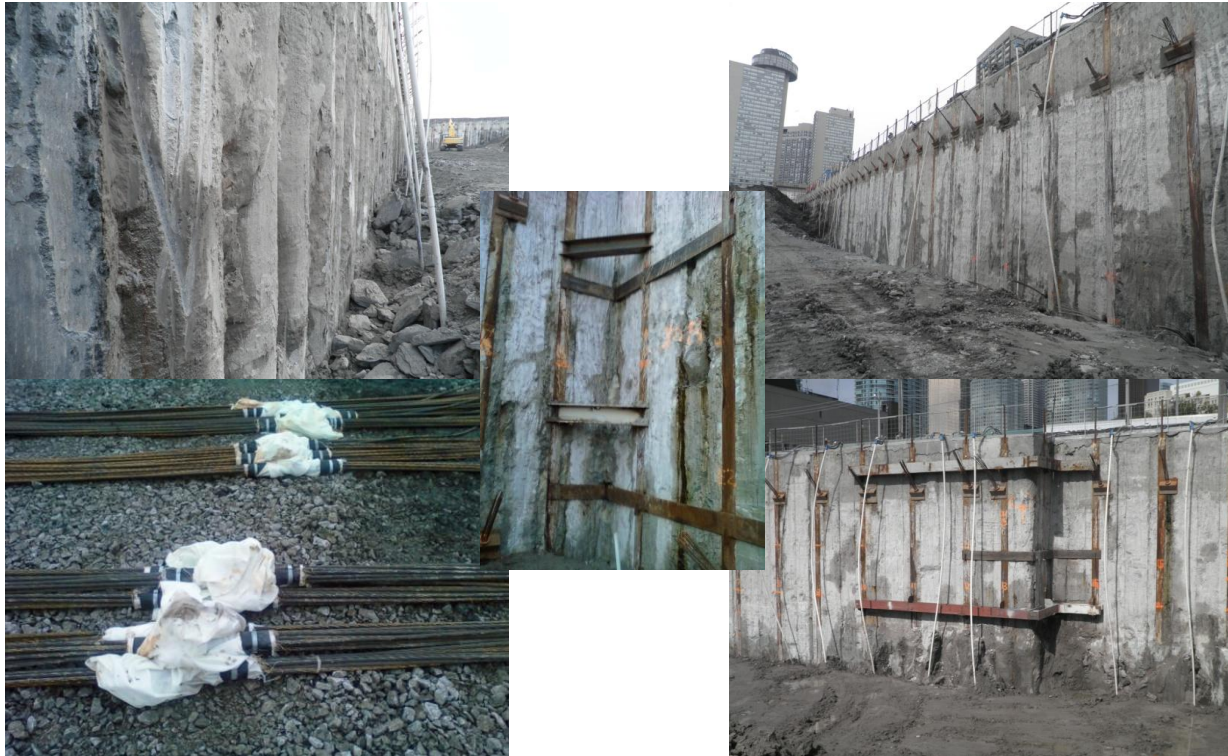
Figure 4 shows five different photos including unshaved caisson wall, shaved caisson wall and stressed upper tiebacks, grout bags, two levels of external walers, and two levels of corner braces.

Figure 4: Pier 27 From Top Left To Bottom Right, Centre: Unshaved Caisson Wall; Shaved Caisson Wall And Stressed Upper Tiebacks; Grout Bags; Two Levels Of External Walers; And Two Levels Of Corner Braces (Source: Isherwood Associates)

Pier 27 used two levels of rock anchor tiebacks that were drilled using auger and grout bags to prevent water leakage into site. Two performance tiebacks were completed at Pier 27 and both indicated the design adhesion was adequate.

There are two different types of walers used as a lateral support system; internal and external. Internal walers are normally used for soldier pile and lagging systems where two tiebacks have been drilled in the same lagging bay. The tieback connections are welded to the internal waler for bracing and the internal waler is welded to the piles. Internal walers are also used in corners on soldier pile and lagging to assist the stabilization of the load of the corner piles. External walers are typically used in combination with external supports such as rakers, corner braces, and struts to help transfer the load to the supports. They may also be used when a tieback is unable to attain the desirable design load.

Corner braces are lateral support systems that are installed in the corners of the shoring system where tiebacks are not practical. They are used in compression to transfer the load from neighbouring piles across the corner. Corner braces can also be used to help transfer the load of external walers to a neighbouring shoring wall. Corner braces may be preloaded.
