The Failure of the Kamaishi Tsunami Protection Breakwater

Jacob Tucker

Memorial University of Newfoundland
St. John's, NL, Canada
jacobt@mun.ca

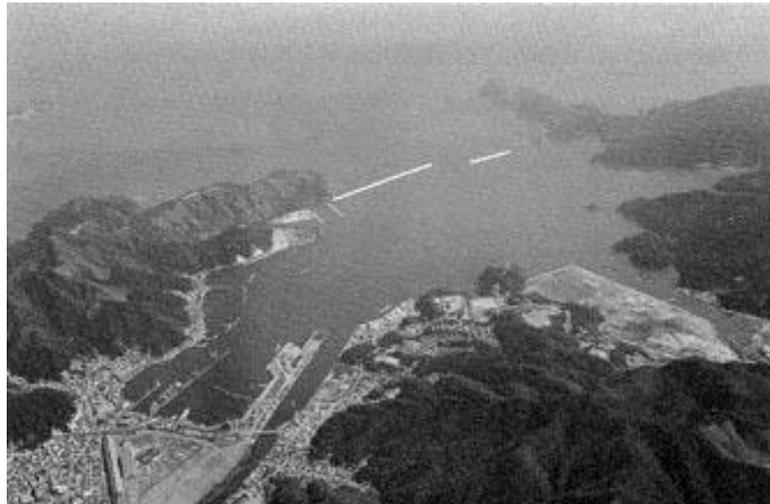
When originally considered, the breakwater at Kamaishi would be constructed in a location where more than 50% of its total length would be comprised of a section deeper than 50 meters. At the deepest point, the breakwater would be approximately 63 meters deep, setting the Guinness World Record for deepest breakwater. Construction of the breakwater started in 1978 and was completed in March of 2009.

Figure 4: Aerial view of the breakwater across Kamaishi Bay

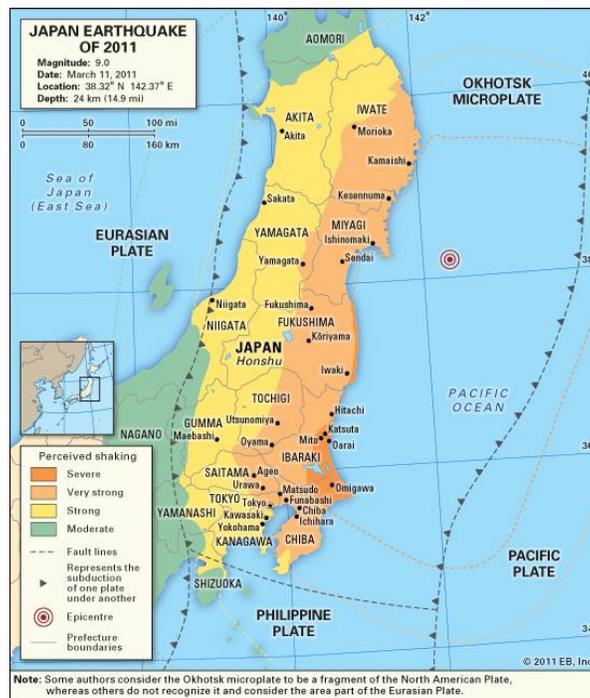
Figure 6: Map showing Great Tōhoku Earthquake epicentre and severity

On March 11, 2011, two years after the completion of the Kamaishi breakwater, Japan was devastated by one of the strongest recorded earthquakes in history. Referred to as the Great Tōhoku Earthquake, it measured a magnitude of 9.0, making it the strongest recorded earthquake to strike Japan, and the fifth strongest recorded earthquake. The epicentre of the earthquake was located approximately 130 km off the Eastern coast of Japan, to the Southeast of Kamaishi, as shown in the figure below.

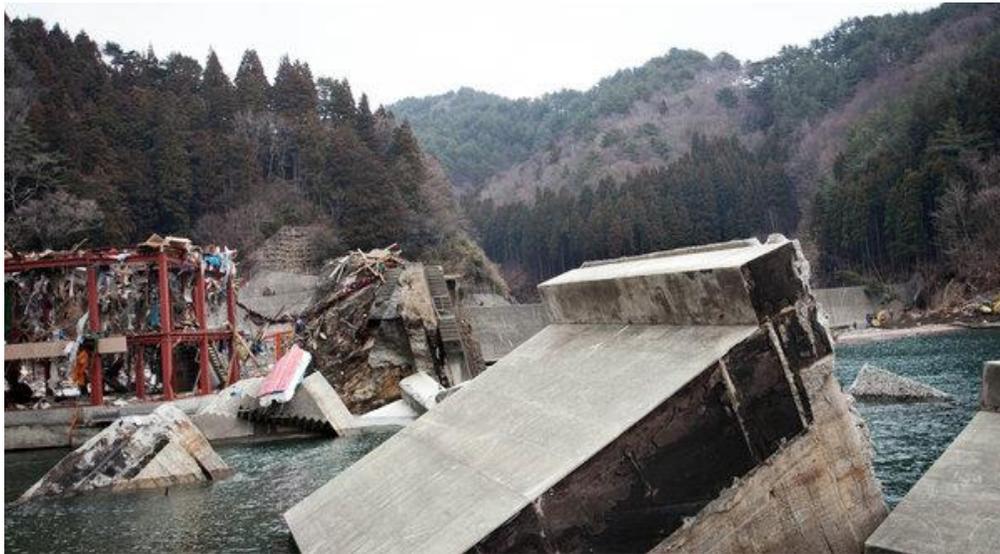
The Kamaishi breakwater failed when it was overtopped by the first wave of the tsunami, measuring at 4.3 meters. Although the breakwater was designed with the intention of resisting the force of tsunami waves, the design simply did not account for a wave of such devastating natural force. When considering design, tsunami waves are considered to be unbroken waves and translated into a hydrostatic force on the face of the structure. In the case of Kamaishi, the design wave was simply tamer than the wave which actually struck the breakwater.

Figure 7: A section of the destroyed Kamaishi breakwater

The fact remains that the breakwater was designed to withstand a smaller tsunami, but the unpredictable nature of seismic activity proved to be the true cause of failure. The extensive research into the design of the breakwater proved that the structure could withstand seismic action and tsunami forces, just not at the magnitude of one of the most powerful earthquakes in recorded history.

In the wake of the Great Tōhoku Earthquake and accompanying tsunami, the government of Japan decided to repair the damaged breakwater. This was met with general disapproval from the population, as the repairs could cost up to \$650 million and the breakwater had proven to be unsuccessful in preventing a tsunami from reaching the coast. As far as the population was concerned, that amount of money should not have been spent to repair a breakwater that had failed, especially in an area beginning to see a decline in population. However, the government decided that repairs were the most cost efficient and effective choice and would encourage industry to remain in Kamaishi, as they would feel protected.

Although the population was opposed to the idea of rebuilding a failed technology, it was deemed by the government to be the best option to protect the coast from tsunami action. The government's decision was partially based on repair being the fastest solution in order to prevent industry from closing due to feeling unprotected.
