*PT-2013: Coastal and Ocean Engineering ENGI.8751 Undergraduate Student Forum
Faculty of Engineering and Applied Science, Memorial University, St. John's, NL, Canada March, 2013*

Paper Code. (PT-2013 - Hogan)

Erosion Management on the Holderness Coast

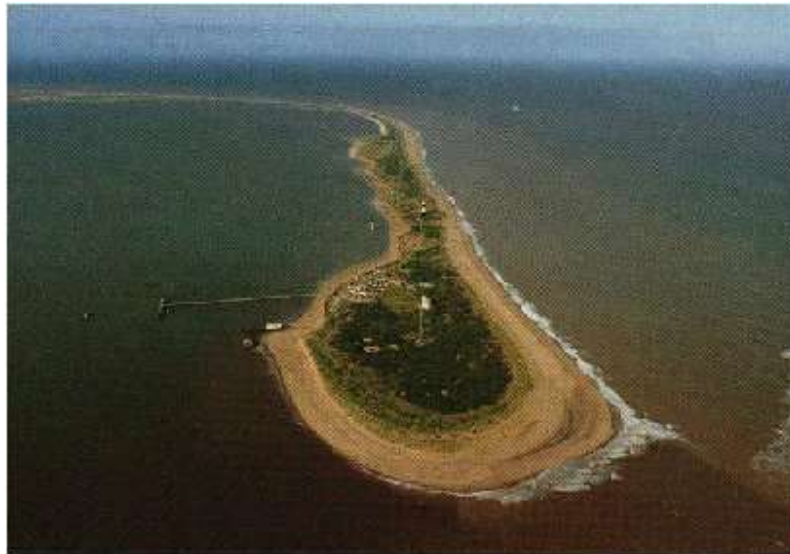
Aside from the large amounts of infrastructure and farmland that has been lost from the coastline to erosion, additional effects have been seen along the southern part of the coast. An example of this can be seen in Spurn Head, which has been identified as a spit. A spit is a landform that occurs from a process of longshore drift. It develops from sediment deposit, building from a head (in this case, Spurn Head) and extending to a nose. While most of the lost sediment moves out to sea, about 3 percent of the total deposits end up at the spit at Spurn head, which can be seen at the bottom of Figure 2 and more closely in Figure 3.

Figure 3: Spit at Spurn Head

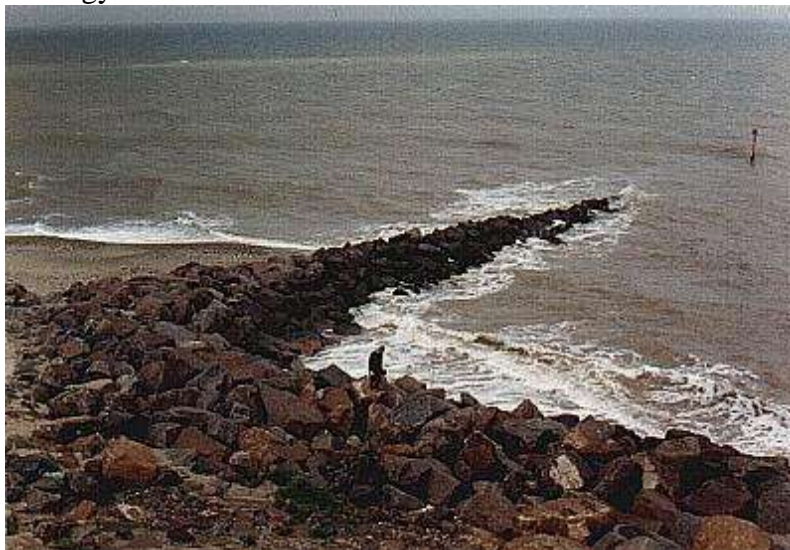
Groynes are structures, most commonly made of wood, that extend perpendicularly into the ocean to help prevent sediment from being washed away by longshore drift. Groynes must be the right length – too long will rap too much sediment and too short will be ineffective in trapping any sediment. They can help to build beaches (seen in Figure 4) or prevent them from being lost. They can also help absorb some of the wave energy.

Figure 4: Rock Groyne

The groynes used along the Holderness coast are built from rock like the one in Figure 4 [5]. While they help to prevent some of the beach sediment from moving down the coast they can also cause issues in other areas. One major problem with groynes is known as terminal groyne syndrome which occurs after the final groyne in a series along a coast. The buildup of sediment near the groyne

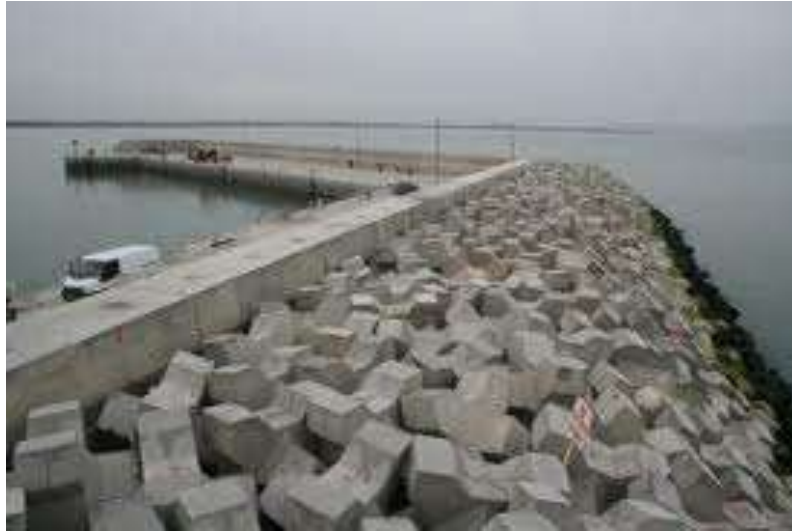
Although breakwaters can be used for other purposes, along the Holderness coastline they are used for lessening the effects of waves. They are normally built out of rock, like in Figure 5, and can be anywhere between 100 to 300 feet offshore [6].

Figure 5: Breakwater

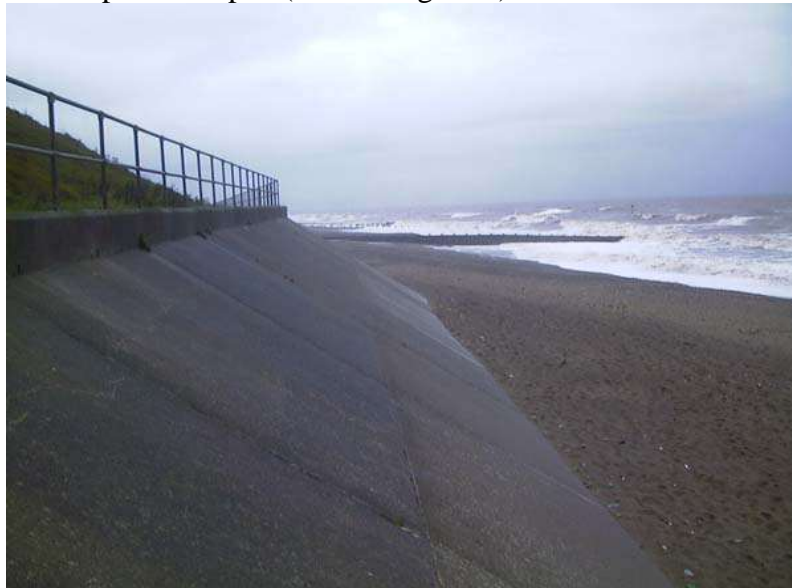
Seawalls help to reflect the incident wave energy back into the sea so that less of the energy goes towards erosion and deterioration of the coast [7]. They can be constructed in various forms including curved, vertical and mound shaped or sloped (seen in Figure 6).

Figure 6: Seawall

Like the other structures, seawalls also come with disadvantages. The reflected energy from the waves can sometimes cause scouring at the base of the wall. Also, the disturbed sediment flow can cause accelerated erosion down drift from the wall.

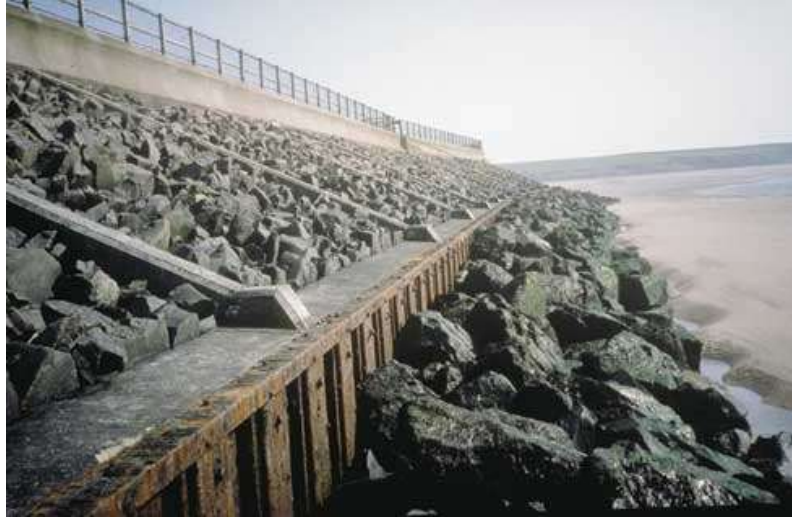
Revetments are very similar to seawalls in their functions and the way they are constructed. They are a sloping structure, usually built up along a dune, commonly out of rock, concrete or both, as seen in Figure 7 [8]. A revetment should be built up higher than waves normally reach to be effective in more intense sea states.

Figure 7: Revetment

The disadvantages found with revetments are similar to those of seawalls. The main issues tend to occur at the ends of the revetment which should be feathered to provide less dramatic erosion effects.

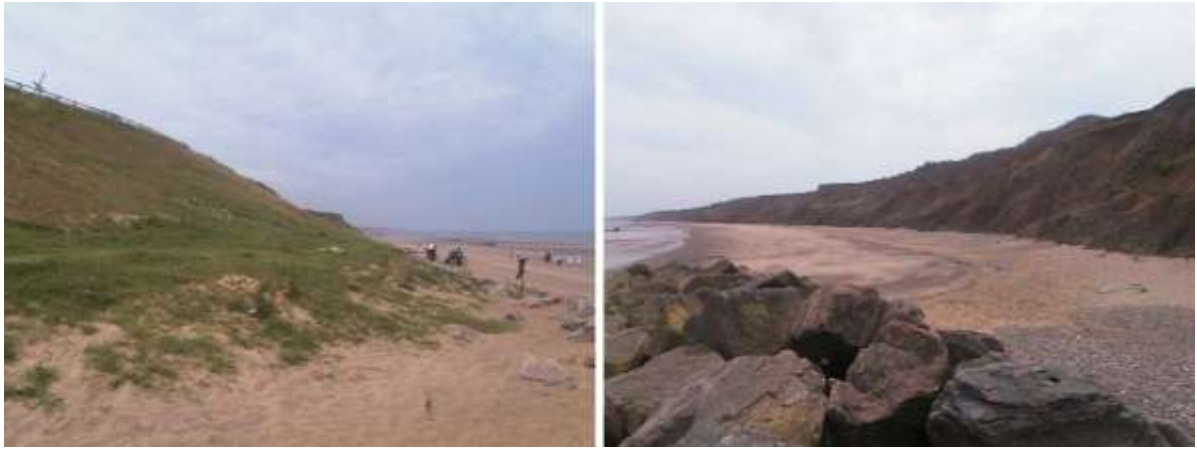
The majority of the coastal management that has been completed to date is near the town of Mappleton. In 1991 approximately 2 billion pounds were spent on coastal defences in the area of Mappleton [1]. The defences consisted of two stone groynes and a rock revetment. The groynes have been successful in preventing erosion and building up the beach south of Mappleton. Towards the North however, there is very little sediment. This can be seen in Figure 8.

Figure 8: Coastline Near Mappleton South(left) and North(right) of the Groyne

The groynes and revetment have for the most part stopped or greatly slowed the erosion in the area of Mappleton but have had negative effects south of the area. Due to the disturbance in the natural movement of the sediments, the beaches south of Mappleton have become narrower, accelerating erosion rates to almost 10 metres per year in some areas [3].
