## **Effects of Ice Loads on the Confederation Bridge**

**Donald Campbell**  
Memorial University  
St. John's, NL A1C 5S7, Canada  
donald.campbell@mun.ca

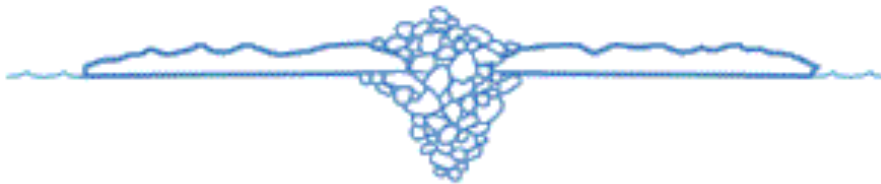
**Figure 2: Typical Ice Ridge Cross-Section** (Source: [www.ec.gc.ca](http://www.ec.gc.ca))

Ridging occurs when two (or more) ice floes collide and the resulting pressure causes the edges of the floes to crumble. Ridges usually occur later in the season as the ice becomes too thick for the floes to raft. They can also occur where an ice floe separates and open water is exposed (e.g. when a floe fails around a bridge pier). The rubble above-water is called the sail and below-water is called the keel. Initially this rubble does not have a high level of strength and poses a hazard only due to its thickness, which is often significantly greater than the floe thickness. Over time a layer of consolidated ice (up to 3 meters) forms as the water between the ice blocks freezes. Ridges with a thick consolidated layer often cause the greatest hazard to structures in ice-covered water due to their strength, thickness and frequency of occurrence.

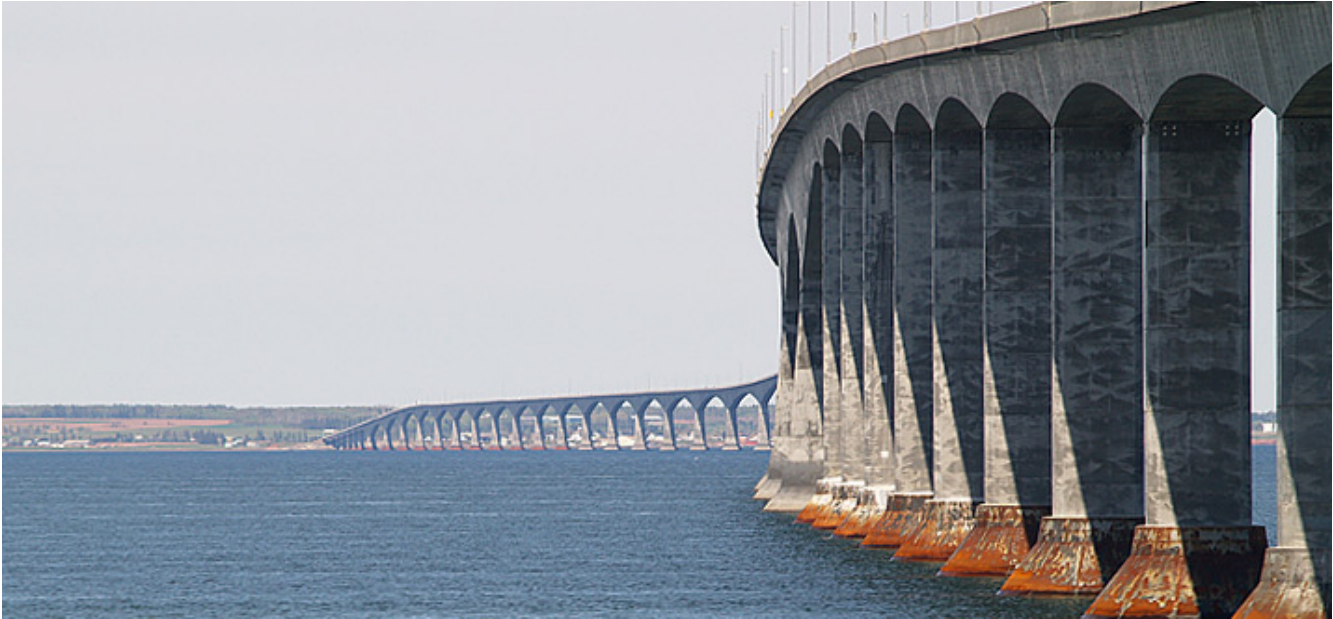
**Figure 4: Corrosion of the Steel Ice Shields on the Approach Bridge Piers**  
(Source: [www.confederationbridge.com](http://www.confederationbridge.com))

The ultimate failure of the ice shields was caused by two separate conditions. Firstly, as water that was trapped between the pier and shield froze it would expand; this expansion could have lead to local deformations in the steel. Secondly, the cathodic protection used to protect the steel from corrosion was ineffective in some areas leading to corrosion of both the internal and external faces of shields, significantly weakening the steel. It is likely that the shields on the approach bridge piers have remained in better condition than those on the main pier because the fast ice located close to shore does not put as much stress on the shields. Nevertheless, even the ice shields on the approach bridge piers have corroded significantly.
