## **The Sir Ambrose Shea Lift Bridge**

**Vince Kerrivan**

Memorial University of Newfoundland  
St. John's, NL, Canada  
n52vek@mun.ca

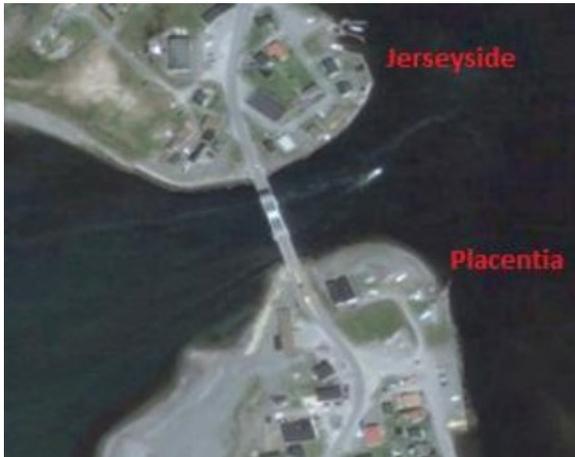
**Figure 1: Aerial photograph of Placentia gut.**  
(Source: Google Earth)

The Sir Ambrose Shea Lift Bridge (figure 1&2) is a vertical lift bridge located in the town of Placentia, Newfoundland. The bridge was built in 1961 to allow vehicles to cross the Placentia gut while still allowing fishing vessels to pass underneath. The Sir Ambrose Shea is said to be unique not only to Canada but all of North America. Prior to the construction of the lift bridge, there were several other methods of crossing the gut with varying success. Over the past decade there has been a growing concern of the safety and structure of the bridge, due to its deteriorating condition as it surpassed its life expectancy in the community. The following information will focus on the history of crossing the gut, the design of the bridge, current state of the bridge and the future possibilities of a new bridge for the residents of Placentia.

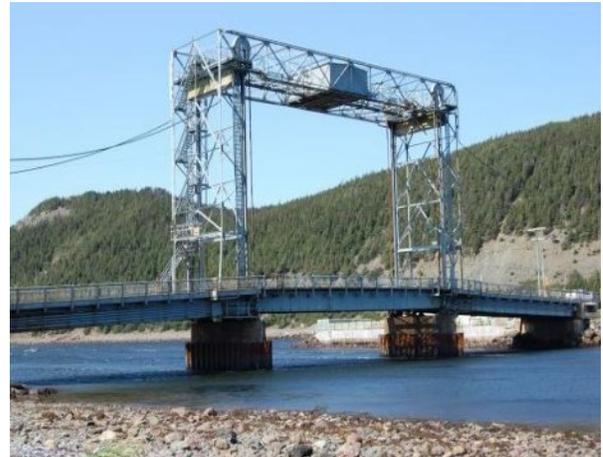
**Figure 2: Sir Ambrose Shea Lift Bridge**  
(Source: Google Earth)

The bridge needed to accommodate both vehicles crossing over it and fishing vessels underneath it. The selection of a vertical lift bridge accomplished both these requirements. The Sir Ambrose Shea lift bridge consists of two stationary approach spans and one centre vertical lift span. All three spans are 100 feet in length. The clearance under the centre span is 10 feet when the bridge is down and 70 feet when fully lifted. The centre span weights 100 tonnes and can be fully lifted in 90 seconds. The bridge was designed to have a lifespan of 50 years. [8] The maximum vehicle load allowed on the bridge is 25 tonnes for tandem axle trucks and 37 tonnes for combination units. [3]

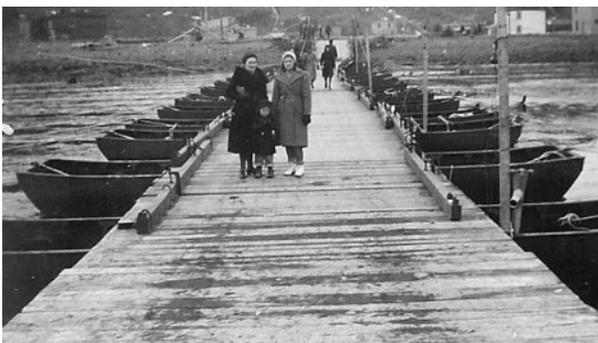
**Figure 3- Placentia Pontoon Bridge, 1941**  
(Source: <http://www.nlgeotourism.com>[F])

A motorized ferry became available on Sundays, holidays and for funeral processions and a smaller boat was used for daily crossings. However, this was not the answer as this service became discontinued and individuals preferred to use privately owned dories to cross the gut. It was apparent a more consistent structure needed to be built. Finally in 1941 a member of the Newfoundland constabulary expressed their concern for a safer more effective way to cross the gut. During this period, the U.S Military had a base set up in a nearby town, Argentia. They built the first and only pontoon bridge in September 1941 (Figure 3). However, due to the strong tide, ice conditions, and currents the bridge was destroyed in December 1941. [2]

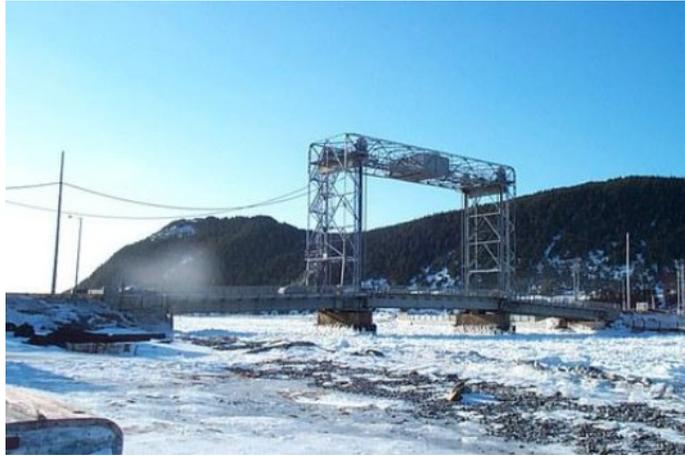
**Figure 6: Ice loading on Ambrose Shea Lift Bridge.**  
(Source: Google Earth)

Although ice does not form every year in and around Placentia Bay, in some years a substantial amount of ice can form. Depending on the winter conditions, ice loading can become a significant factor on the bridge. The area around the bridge can form a bottleneck where ice can build up. The

strong tides under the bridge can provide high driving forces, pushing the ice against the bridge. This could lead to high loads on the bridge piers depending on the crushing strength of the ice.

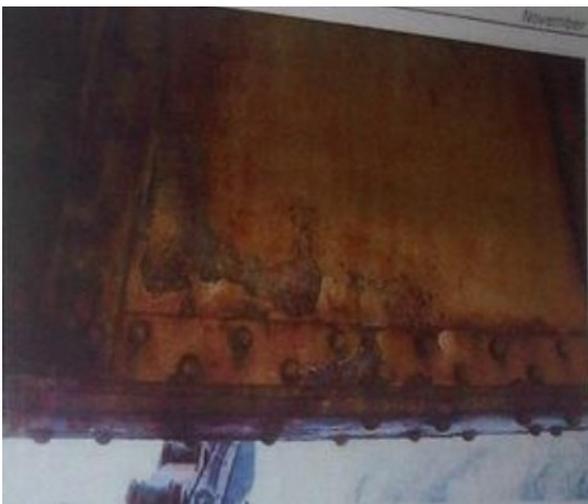
**Figure 7: Failure of structural steel coating system**  
(Source: Delcan Inspection Report, 2011)

While routine maintenance was continuously performed on the bridge since its opening in 1961, major issues became of concern when a full structural analysis was completed in 2011. It was known and expected that some corrosion would be found, however the damage was much more than expected. The main counter weight ropes were corroded far beyond acceptable limits, accident damage was never repaired on the beams, failure of the steel platform at the rope connection to the main grinder and the structural steel coating system failed leading to corrosion and failure of several members.

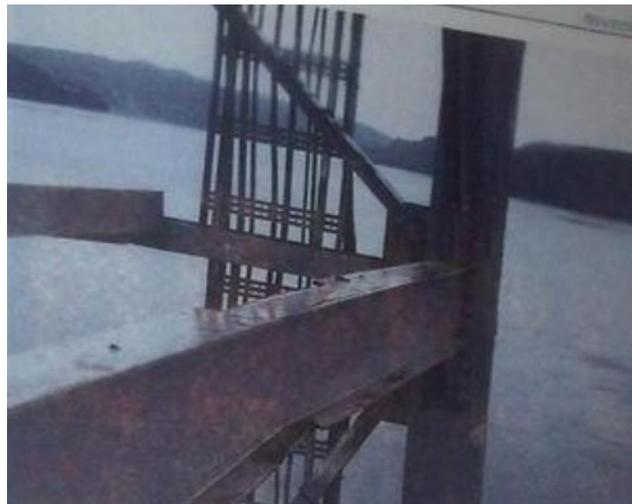
**Figure 8: Deformation due to accident damage**  
(Source: Delcan Inspection Report, 2011)

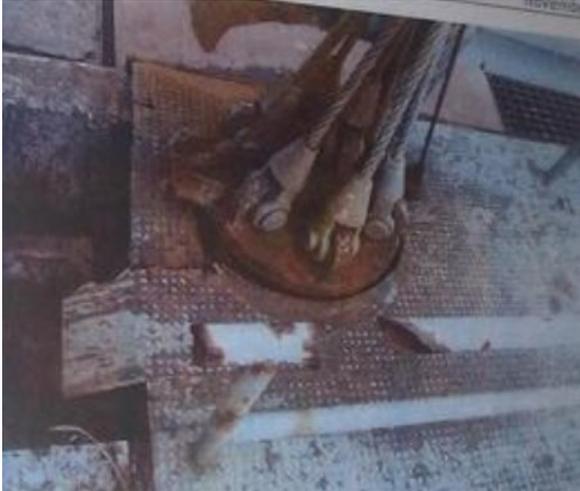
**Figure 9: Failure of steel platform**  
Source: (Delcan Inspection Report, 2011)

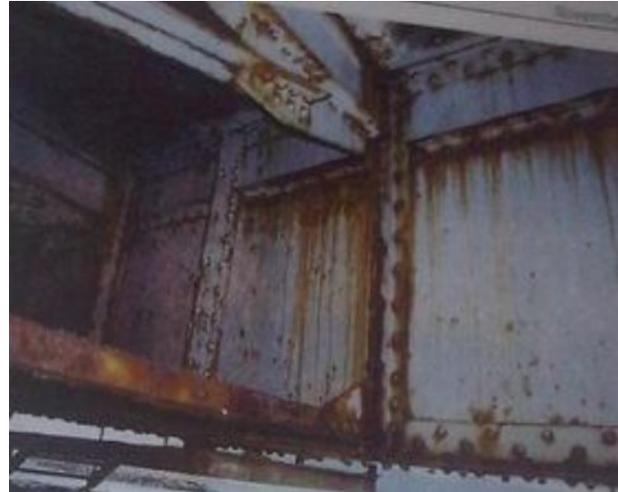
**Figure 10: Typical severe corrosion at main girder**  
Source: (Delcan Inspection Report, 2011)

The greatest challenge for longevity of the bridge is corrosion. The bridge's close proximity to salt water makes it susceptible to rust especially at the piers and near the foundations.
