The Role of Business and Engineering Decisions in the Deepwater Horizon Oil Spill

Mark Reynolds

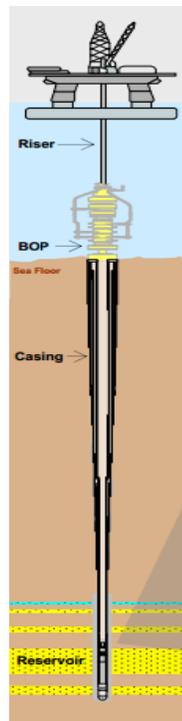
Figure 2 – Deepwater drilling schematic [7].

To prevent gas from leaking up the outside of the well pipe, cement is pushed between the casings and the bedrock. To seal the space between casings (called an annulus), an o-ring (or liner hanger) is used [6]. A device called a shoe track is also placed at the end of the last casing during cementing to prevent flow from the annulus back into the casing [7].

Contractor Halliburton was responsible for design and placement of the cement mixture. Lightweight slurry was required due to limited pore pressure in the area. To achieve the required low density, foamed cement was used. The mixture was created by injecting nitrogen gas into the concrete, which also causes “increased slurry compressibility, increase set-cement elasticity, and the flexibility to vary density during operations” [9]. There were some major risks associated with this cement design and placement, including the fact that the foam was relatively unstable, and was subject to contamination because such a small volume was used. These risks were known and accepted by both BP and Halliburton.

Because nitrogen broke out of the cement slurry, the cement failed and hydrocarbons were able to escape through the shoe track and back into the riser. In addition to the cement failure, an additional check valve failed, allowing hydrocarbons to enter the riser. This valve failure has also been confirmed by Macondo static kill data [7].
