The Usumacinta Disaster

Chris Hanlon

Memorial University
St. John's, NL A1C 5S7, Canada
cmhanlon@mun.ca

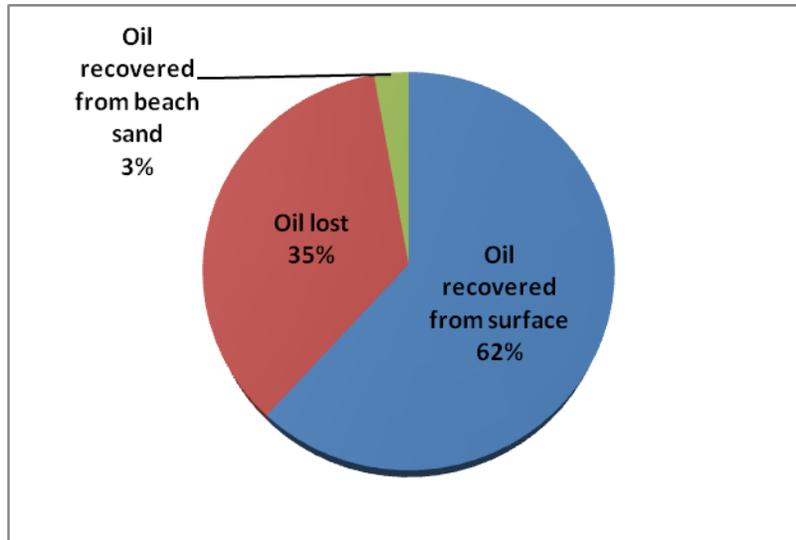
Control teams were sent to the Usumacinta to assist in containing the oil spillage and terminate the leakage but were severely delayed due to the rough sea conditions and the hazardous gases released in the leakage. Initially spill was estimated to leak 442 barrels of light crude a day. PEMEX estimated that approximately 40% of this spillage was evaporated. PEMEX used a variety of chemicals to recover the lost oil and successfully obtained a total of 8701 barrels.[2] PEMEX estimated however that 5000 barrels of oil were unable to be recovered. PEMEX noted however that the leakage was more gas than oil which was impossible to retain and was left to enter the environment. Additionally some spilt oil was observed to have been absorbed into beaches nearby the oil well. PEMEX reported the recovery of over 500 tons of sand with hydrocarbons that is estimated to be equivalent to 394 barrels of oil. [2]

Figure 6: Oil Recovered and Lost
