The Ocean Ranger Disaster

Brent Marsh

Memorial University of Newfoundland
St. John's, NL, Canada
b.marsh@mun.ca

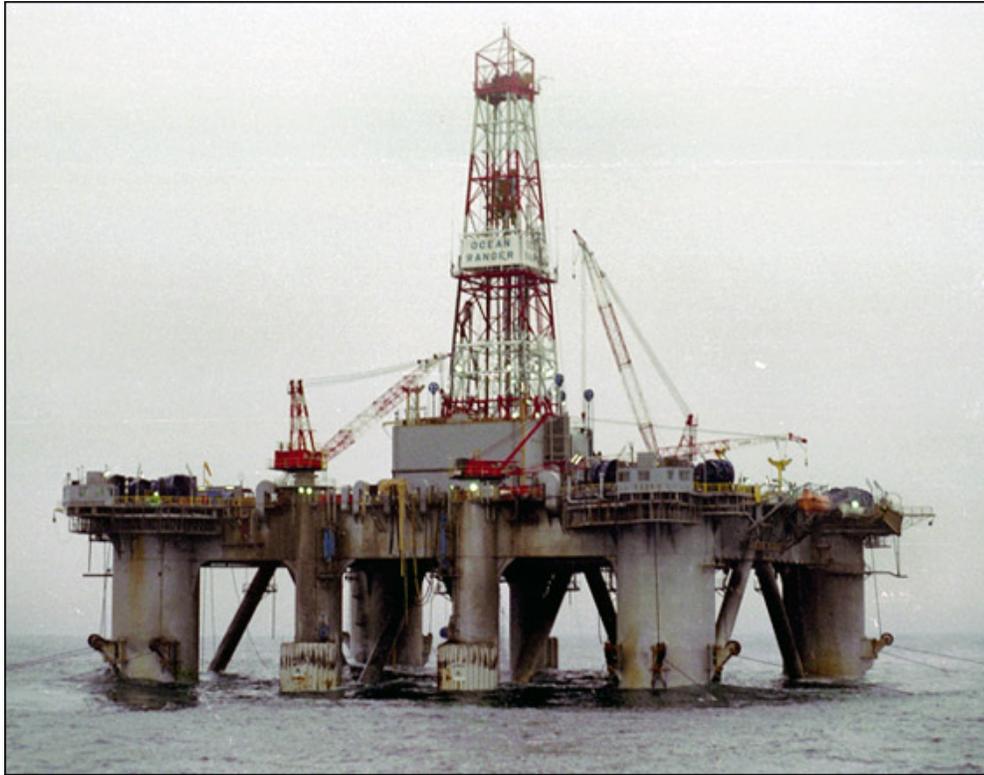
Figure 1: The Ocean Ranger

At 121 meters long, 80 meters wide, and 103 meters tall, The Ocean Ranger was thought to be capable of handling anything that the Atlantic Ocean could give her. Figure 1 demonstrates its impressive size.
