## **Bell Island Lighthouse Relocation Project**

**Amanda Curnew**

Memorial University of Newfoundland

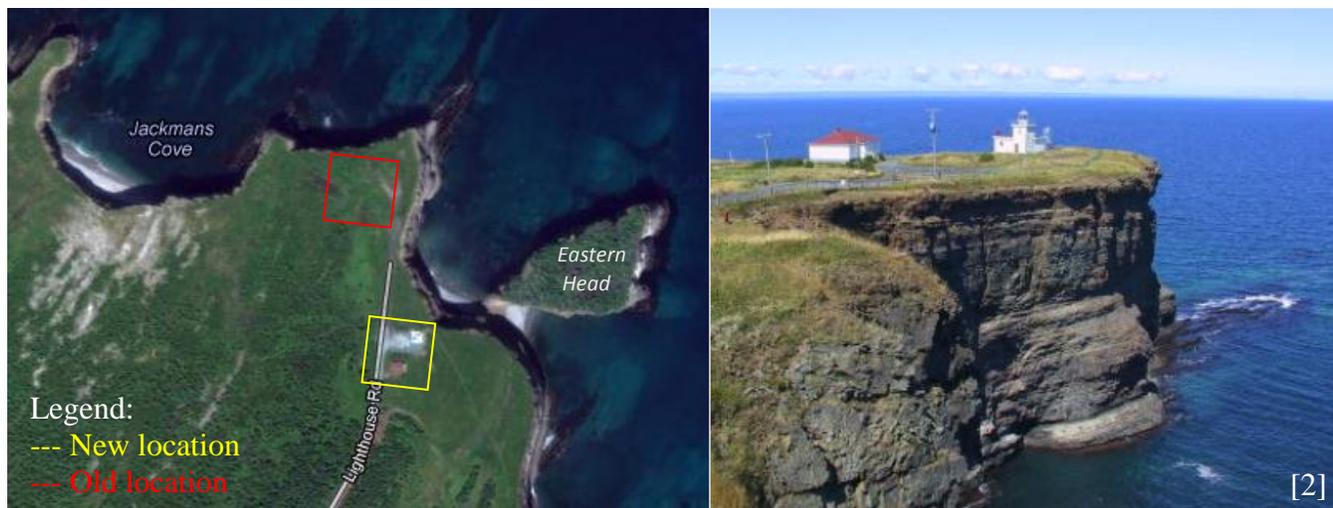
Figure 3: Old Location of the Bell Island Lighthouse

In 2000, the lightkeeper, at that time, had expressed serious concerns to the Canadian Coast Guard that they could hear noises in a cave below the cliffs, near the lighthouse and lightkeeper's residence. With this concern brought to the Coast Guard's attention, they immediately took action to assess the site. A number of studies were completed including a slope stability assessment by AMEC Earth and Environmental Limited, a risk assessment by C-CORE in collaboration with AMEC and a planning options report by Sheppard Case Architects Inc. Through the recommendations and conclusions established in these engineering studies, a final decision to relocate the lighthouse became apparent and justifiable. It is important to note that the lighthouse was not only accessible by the lightkeeper, but rather locals and tourists visiting the lighthouse on a regular basis. Safety was certainly a key deciding factor for relocating the lighthouse; however, other considerations including economics, engineering liabilities and preservation of community heritage were also influential in the overall decision. [3]
