## **The Galveston Seawall**

### **Abstract**

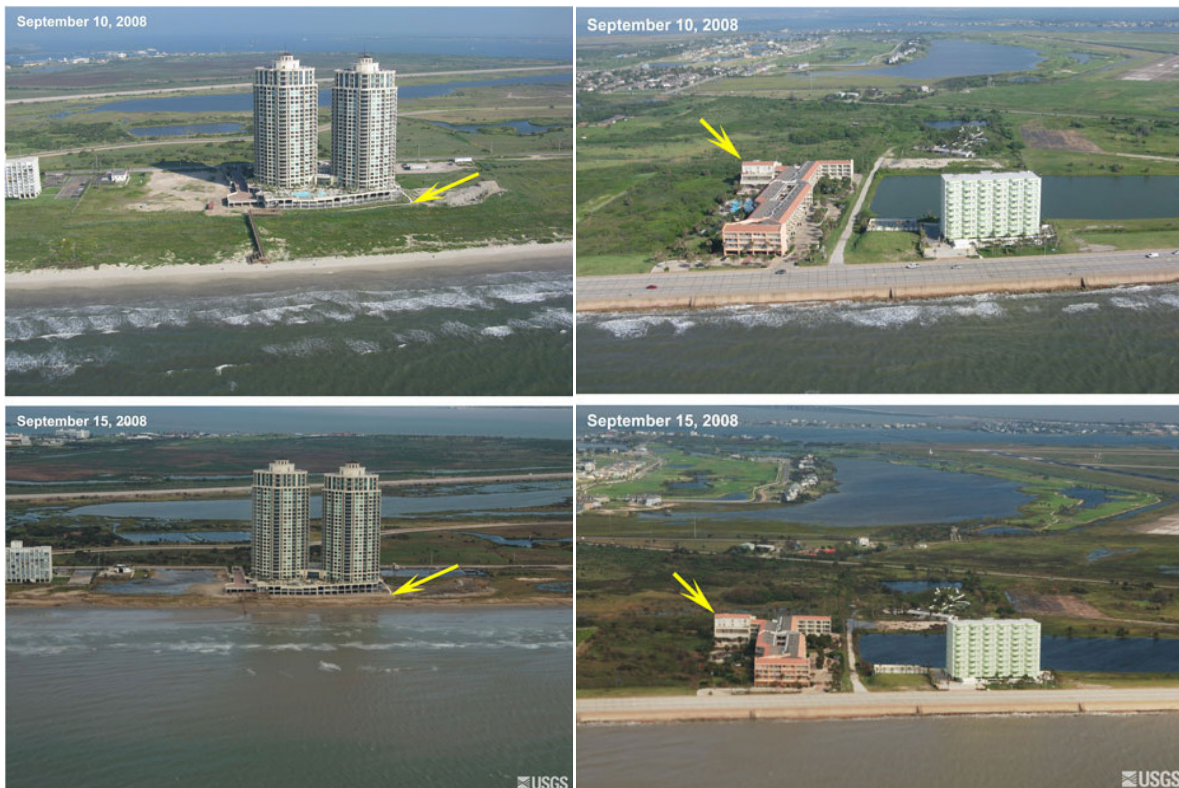
On September 13, 2008, Hurricane Ike made landfall at Galveston. Ike was one of the most devastating storms in the history of Texas, largely due to the sustained storm surge. While Galveston experienced considerable flooding and destruction, the elevated area near the seawall experienced the least damage. As seen in previous storms, nearby communities unprotected by the seawall or natural sand dunes were destroyed or heavily damaged, far more so than Galveston. Considerable beach erosion took place due to Hurricane Ike; however, areas protected by the seawall experienced considerably less erosion, as indicated in Figure 4.

Figure 4 – Coastal erosion due to Hurricane Ike (Image source: <http://coastal.er.usgs.gov>)
