Shoreline Infrastructure in Conception Bay South, Newfoundland

Rob Ducey

Memorial University of Newfoundland
St. John's, NL, Canada
red302@mun.ca

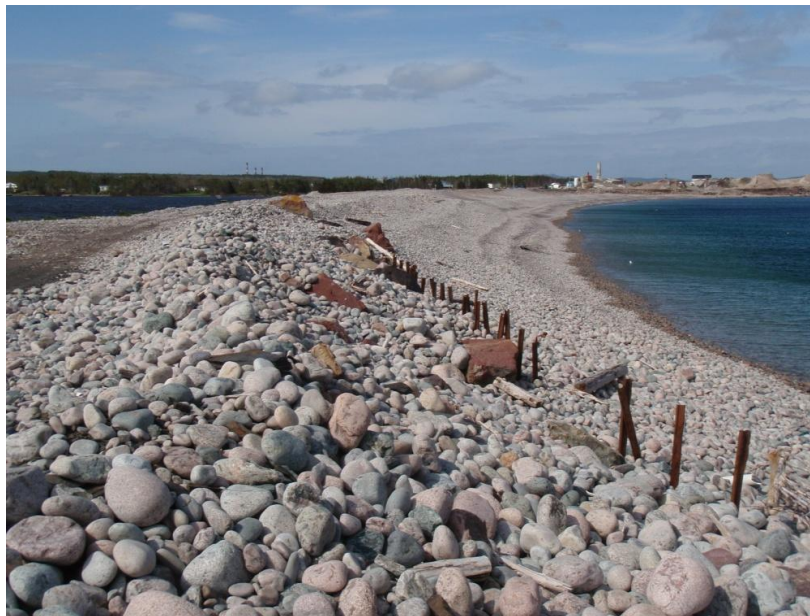
The boundary between Lance Cove Pond and Conception Bay is a breakwater. This breakwater has a shallow slope and the exterior is covered with large cobble stones. The purpose of this breakwater is to shelter the pond in which it surrounds. Lance Cove Pond has many residential houses located around its exterior and due to the protection from the breakwater; this pond is sheltered from the powerful waves generated by the Atlantic Ocean. This shows how a proper breakwater can protect areas that are more susceptible to damage. Figure 2 shows the breakwater with Conception Bay to the right and Lance Cove Pond to the left.

Figure 2: Breakwater location at Lance Cove Pond
(Source: Personal Photo)

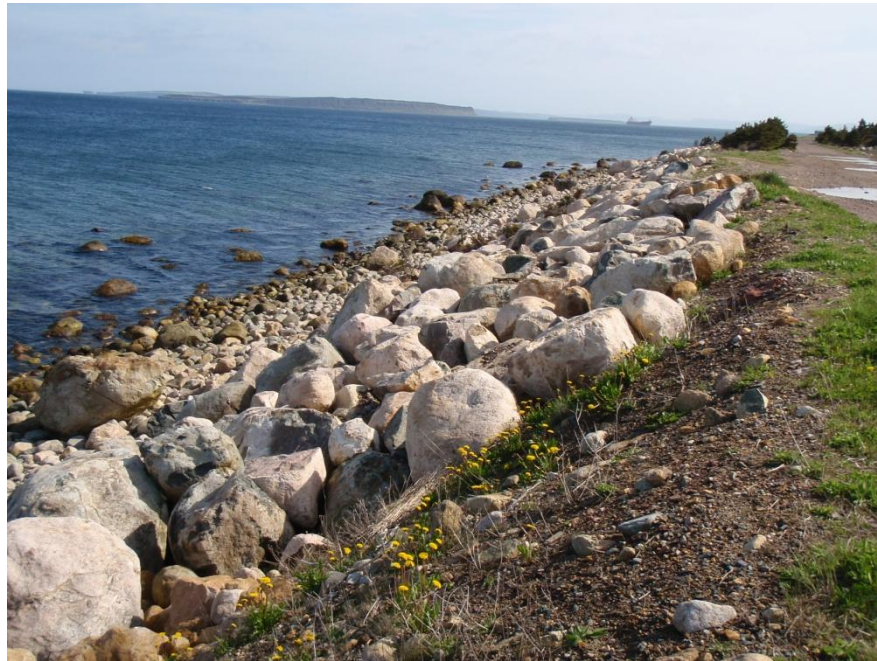
Along the shoreline near Anthony's Road in Conception Bay South lies a revetment. This revetment consists of large armour stone that is placed along the slope of the shoreline. There is a medium slope on this revetment which is designed to disperse the wave energy that hits it. During high

wave action, the waves will ride up the slope until its energy has been depleted and is not harmful to the surrounding area. This helps to protect the water and sewer infrastructure that is buried in the buried just beyond the revetment. Figure 3 shows the revetment with large armour stones protecting the slope.

Figure 3: Revetment located near Anthony's Road
(Source: Personal Photo)

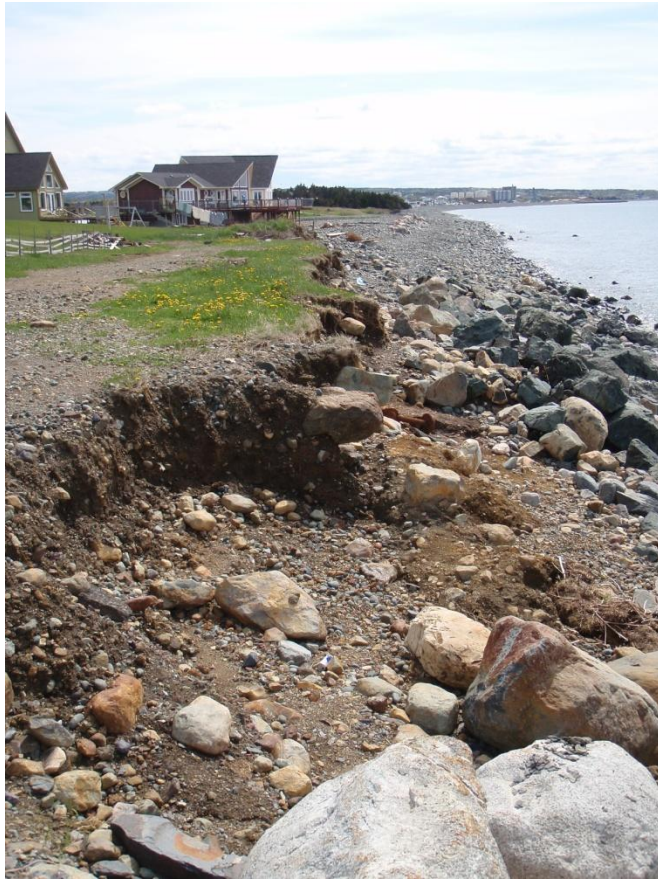
The shoreline that is perpendicular to Cherry Lane in Conception Bay South is eroding away. This is due to the powerful wave action that affects the area. If left alone, this eroded section will soon expose the existing sewermain causing extensive damage to the infrastructure. This would be a major inconvenience to the residents that are connected to this service. Figure 4 shows the extent of the damage that has been caused the waves.

Figure 4: Damaged shoreline near Cherry Lane
(Source: Personal Photo)

If there was a revetment present then this damage would not have occurred. The revetment would have directed the power of the waves up the slope and keeping it from eroding the softer materials that lie beyond it. This would prove to be effective in protecting the buried infrastructure from being unearthed and potentially damaged.

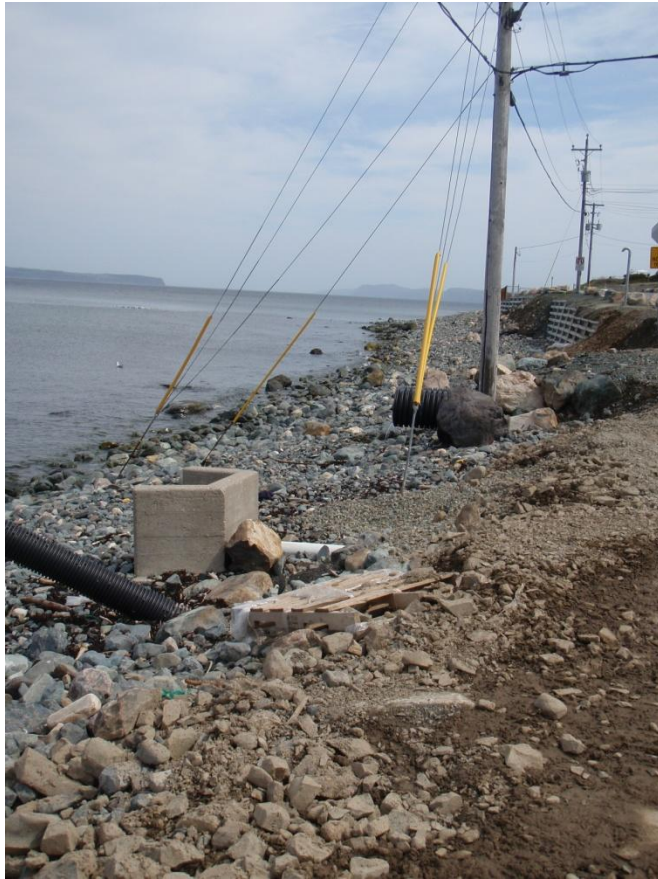
Goodland Road runs parallel to the coast of Conception Bay. The waters of the bay have caused major damage to the shoreline. There is no breakwater or revetment present in this area, so therefore the wave action is at its full intensity. This wave action is exposing the infrastructure that is in the area. As seen in Figure 5, the stormwater pipes that connect to the headwalls are completely exposed. This happened from the pounding waves carrying away the earth around the pipes. These pipes could become severely damaged and have to be replaced, costing the town a large expense.

Figure 5: Exposed infrastructure along Goodland Road
(Source: Personal Photo)

To avoid any future damages, a coastal structure should be built in order to direct the energy of the waves away from the shoreline where important infrastructure is buried.

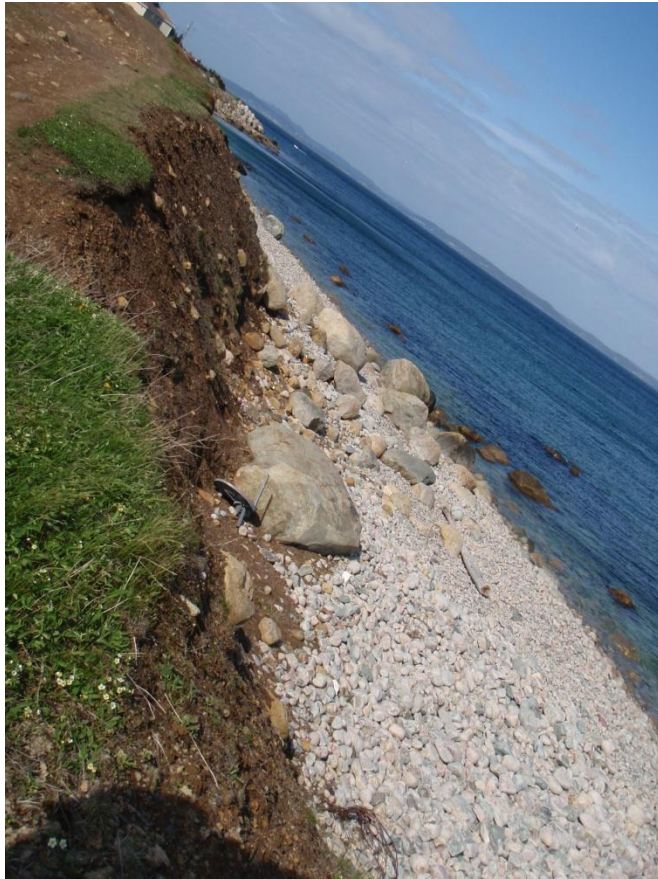
Near Gully Pond Road in Conception Bay South there is a steep embankment that is eroding away due to the wave action from Conception Bay. This embankment has no protection from the powerful waves. There is no armour stone or any rock covering the slope. It is completely cover with topsoil. This material is easily washed away by the ocean during stormy weather.

Figure 6: Steep embankment near Gully Pond Road
(Source: Personal Photo)

To better protect this embankment from eroding further and causing damage to the underground infrastructure, the slope should be cover with a large stone. An armour stone would provide the best defence from the wave energy. The slope and tough materials will help to dissipate the wave energy and prevent any additional lose of ground materials. Figure 6 shows the steep slope of the eroded topsail that is in danger of exposing buried infrastructure.
